**Biotopia
Environmental
Assessment**

ENVIRONMENTAL ASSESSMENT REPORT

Report ID: 240830-1 [REDACTED]
Property: [REDACTED] VIC
Assessment date: 30 August 2024
Report for: [REDACTED]
Date of Report: 11 September 2024
Previous Report ID: N/A

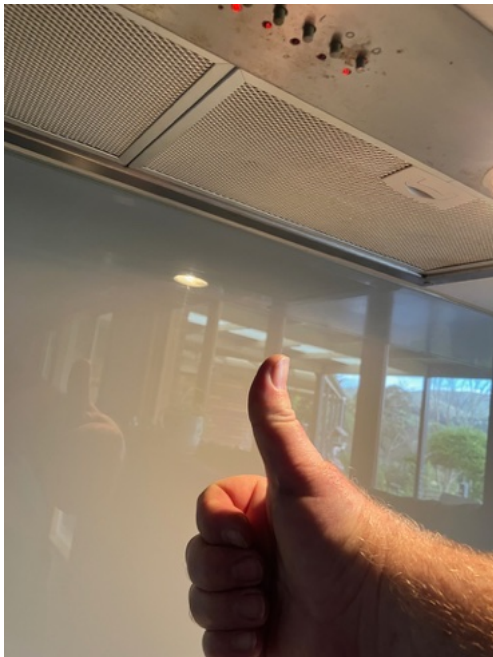
5. The rangehood flow seemed OK, and was plumbed out of the kitchen.

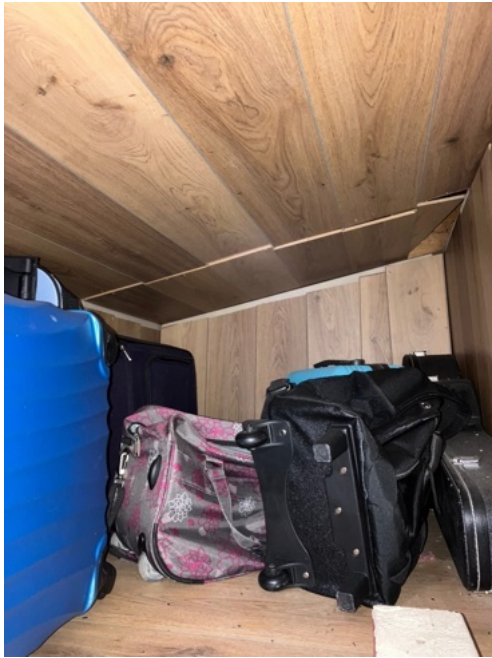
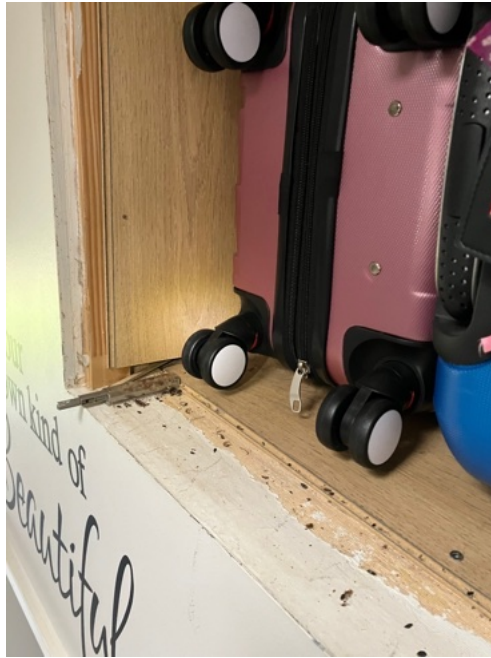
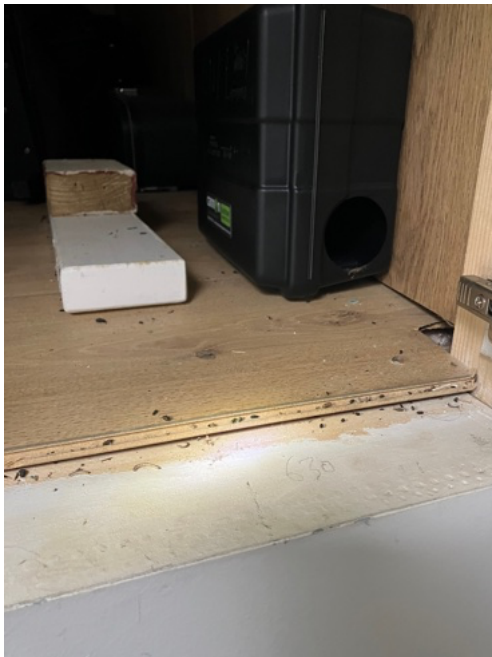
7. The storage hatch. Significant number of mouse droppings despite what seems to be a
470 rodent bait unit.

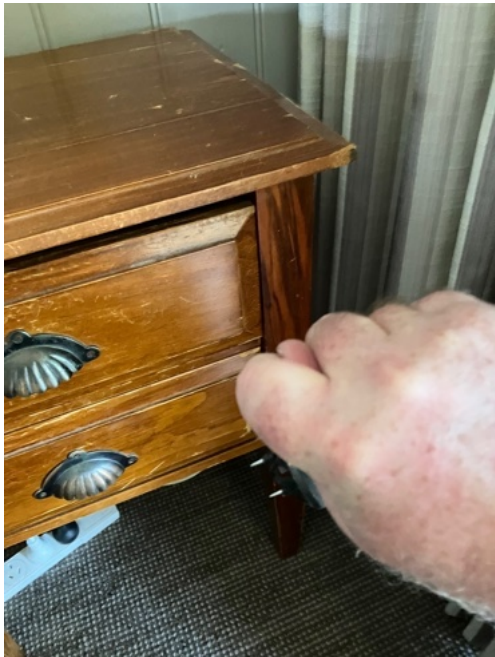
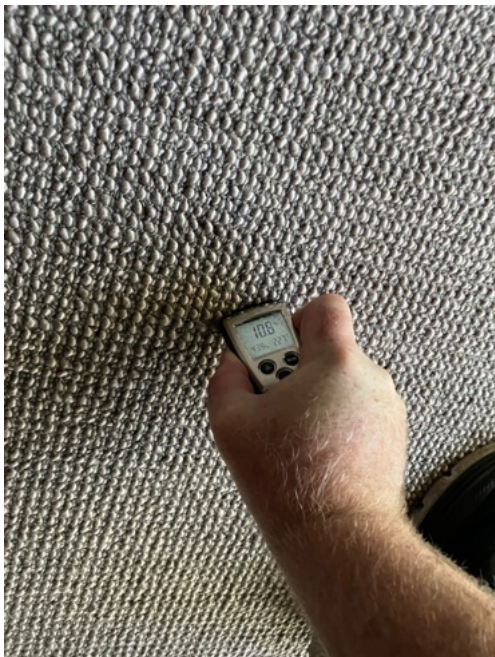
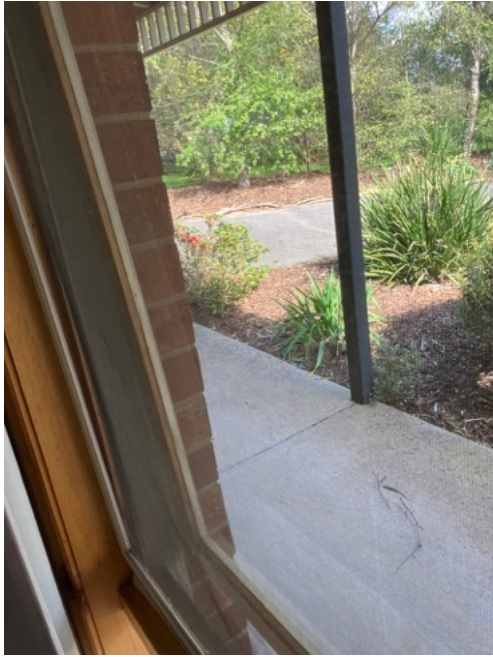
10. The bedroom 2: musty odour. Flooring not especially damp on its upper side under the carpet in various locations. Curtain not especially mouldy. Slight indication of occasional condensation on window panes.

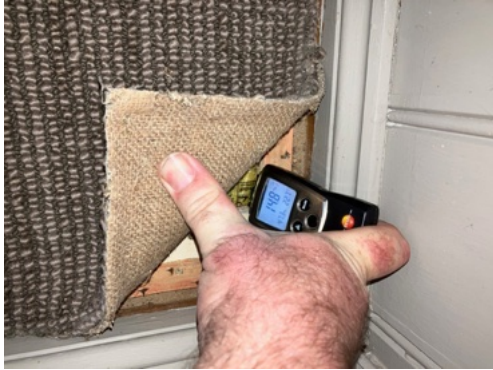
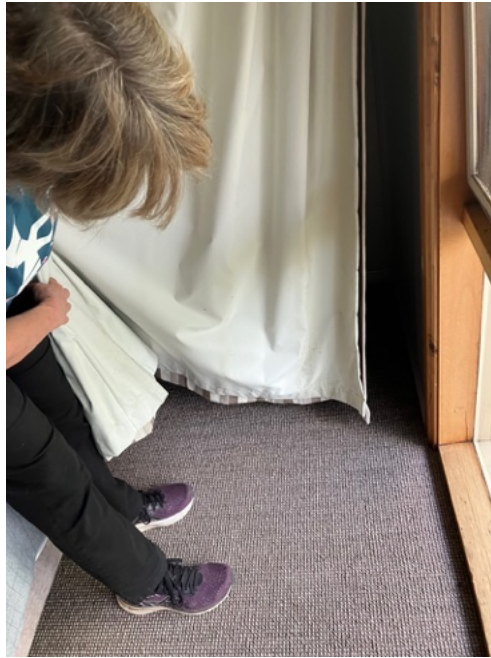
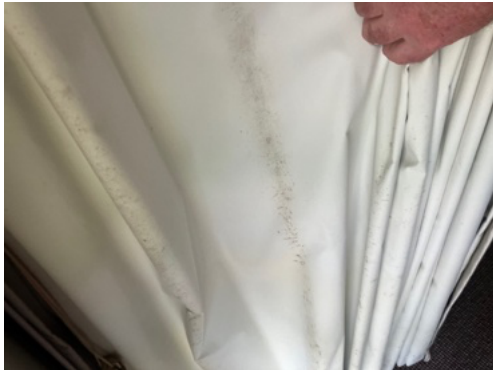
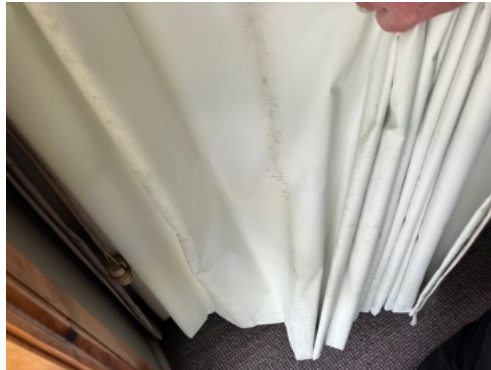
- 490 11. The bedroom 3: flooring quite damp at far corner away from access hatch / bathroom.
Rusted tacks on carpet gripper. Mouldy odour. Visible mould on curtains.

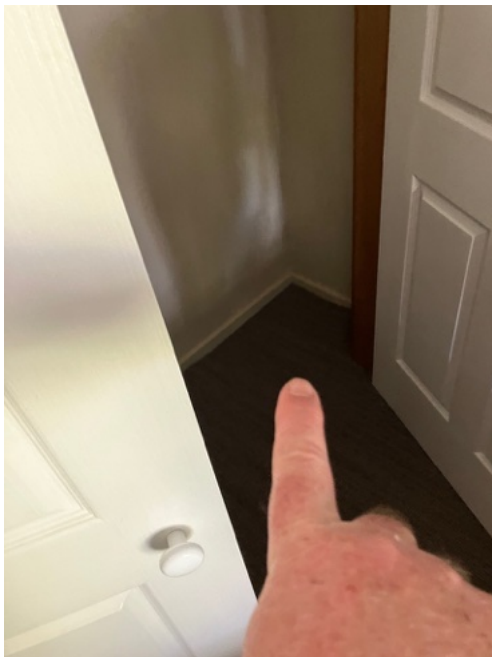
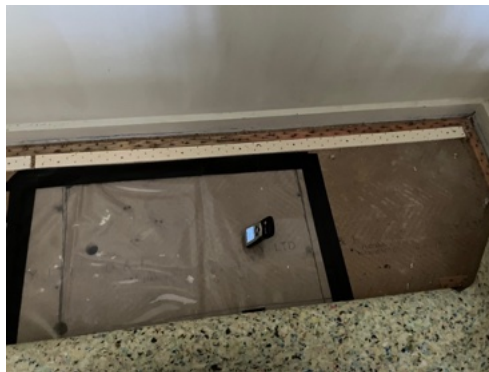
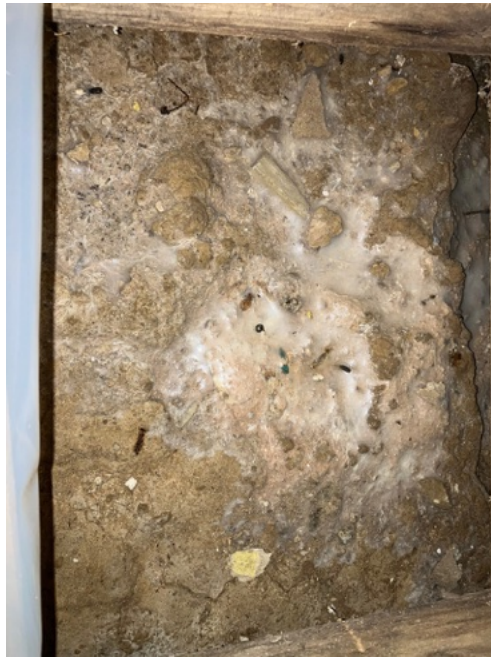
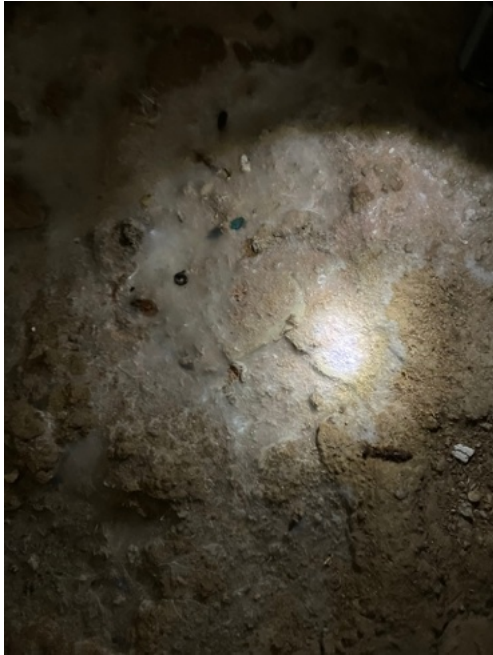
495 **12.** The bedroom 3 hatch into subfloor in the BIR adjacent to the bathroom shower. Hatch
chipboard is wet as also other timbers. Strong mould and geosmin odours. The subfloor soil
surface was wet and covered with a strange fibrous substance that may have been great
amounts of fungal hyphae, but this is unclear. Definitely the underside of the chipboard
flooring was visibly mouldy (pale dusts often in fingerprint sized colonies / patches, as typical
500 of *Penicillium* and some *Aspergillus* species in these conditions). Soil is heaped up at this
exact location, but slopes off to a possible height of about 300 mm at the high-side of the house
to about 700 mm – 1 m at the low side. It is theoretically possible for a person to crawl under
the house, but would be quite difficult to get under the bathroom and bedrooms in a manner to
effect meaningful remediation.

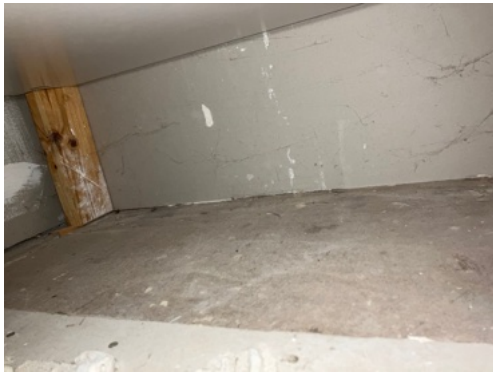
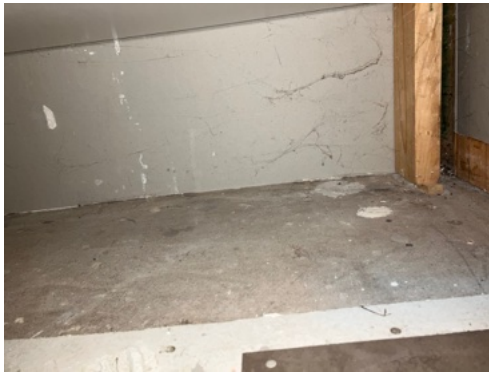
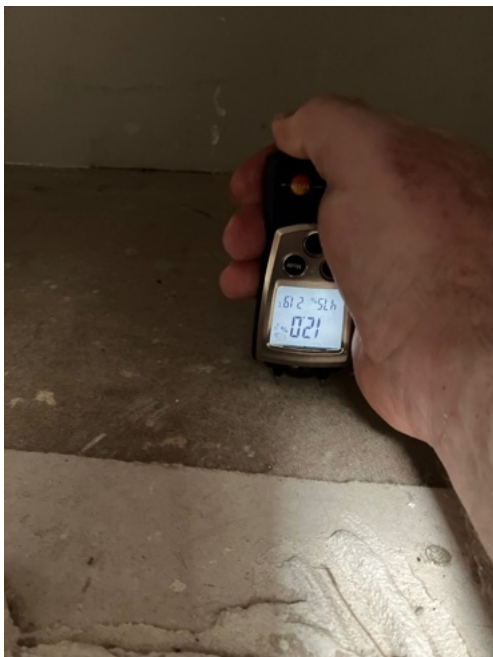
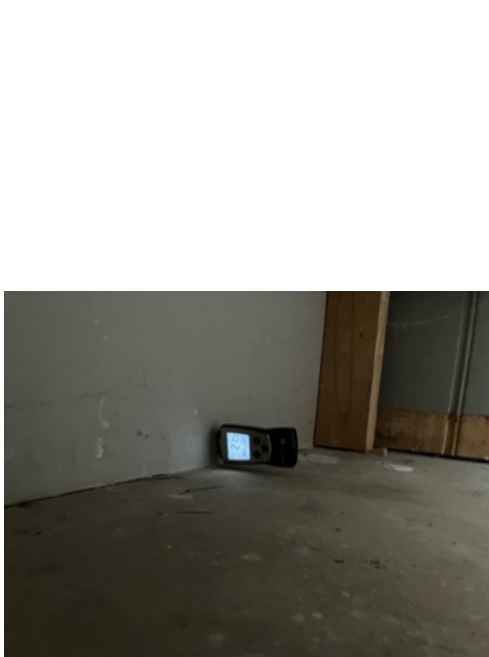
14. The bottom of the cupboard in the hallway behind the central bathroom: no evident damage, nor moisture by meter on upper surfaces of boards and backing of shower that is visible.

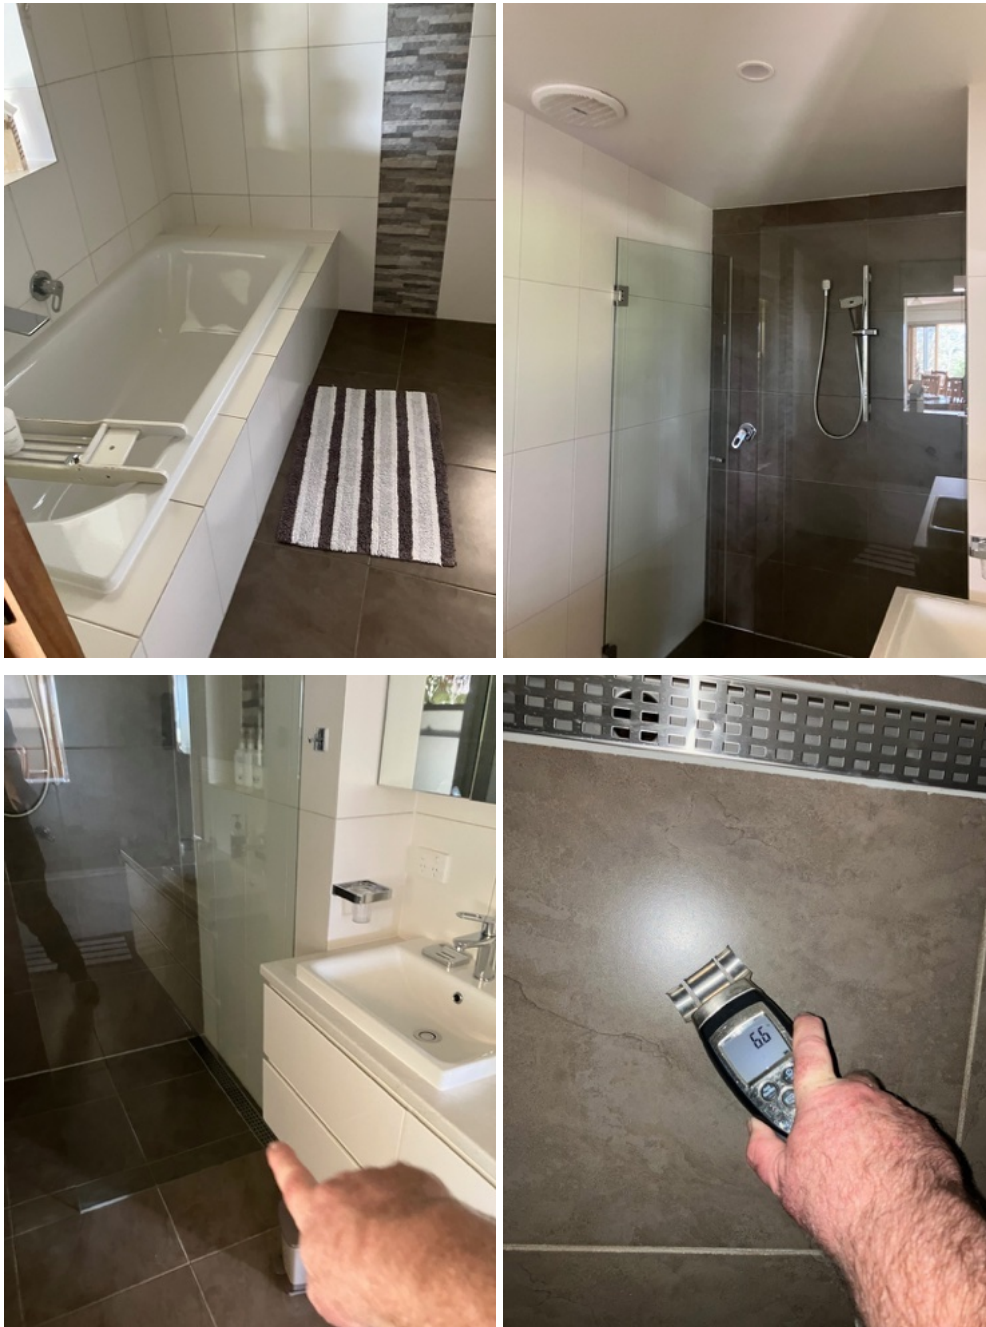
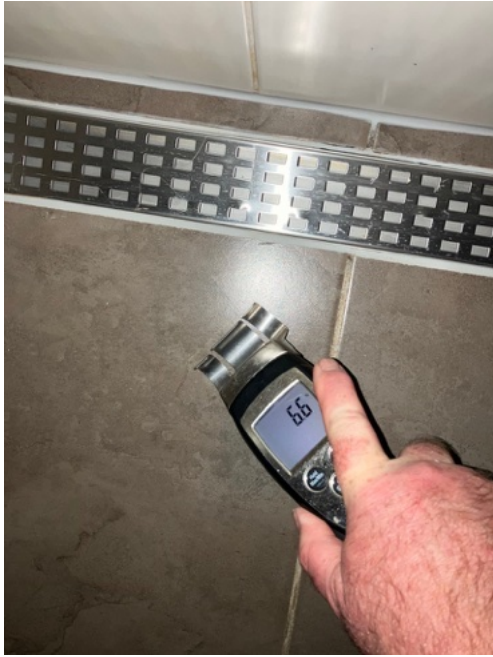
15. The central bathroom. Shower base is damp, walls dry, but not consistent with an actual leak from the shower, instead more consistent with significant dampness below the shower base and elsewhere under the tiles.

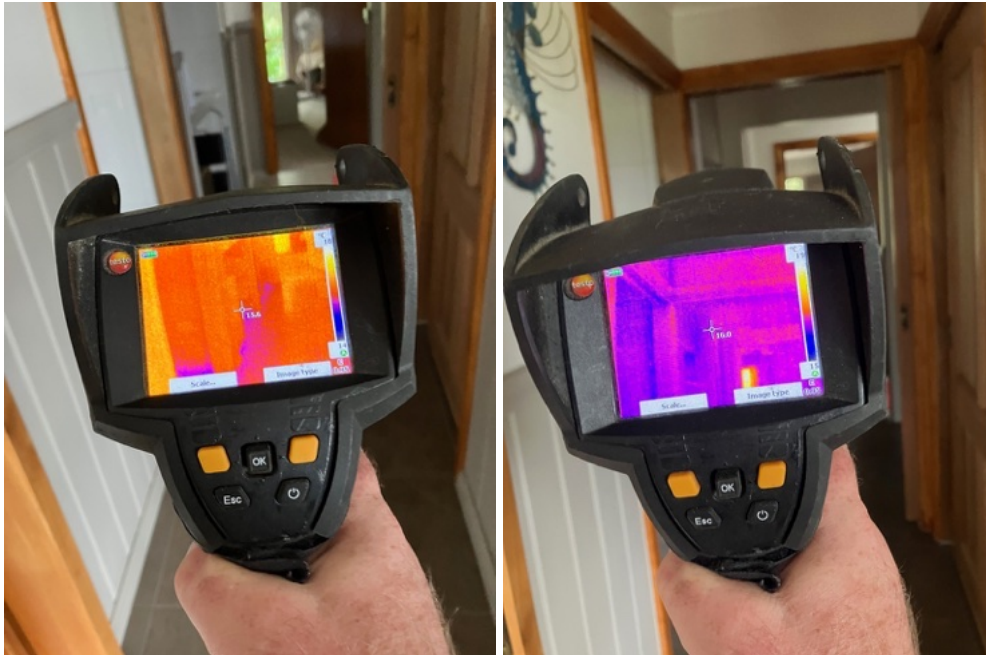
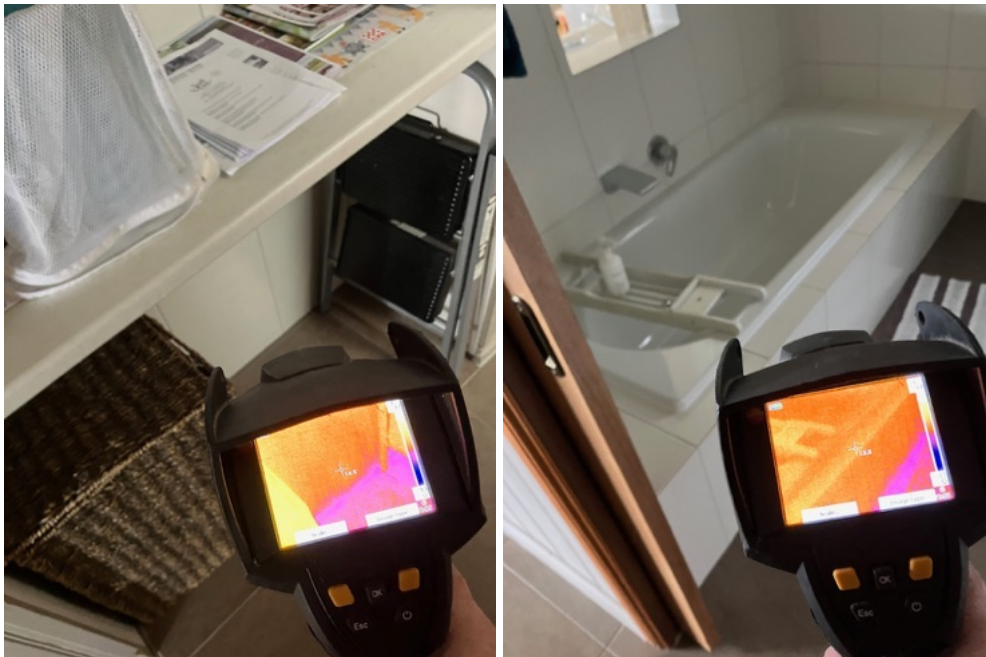
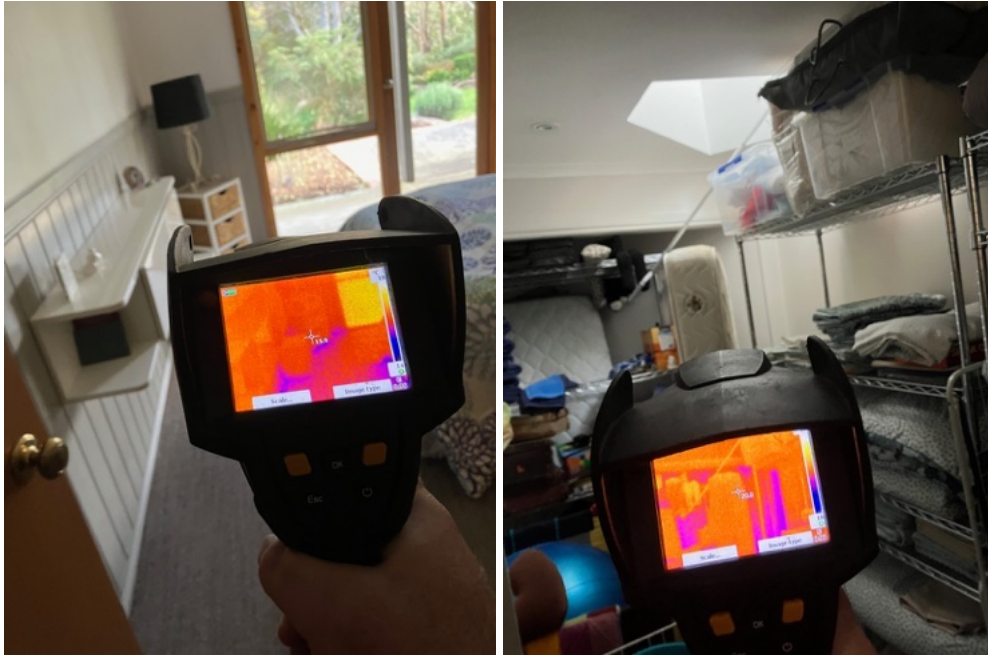
16. Thermography was unspectacular (subset only shown): not consistent with significant roof or skylight leak / ceiling dampness, nor tub leak, etc.

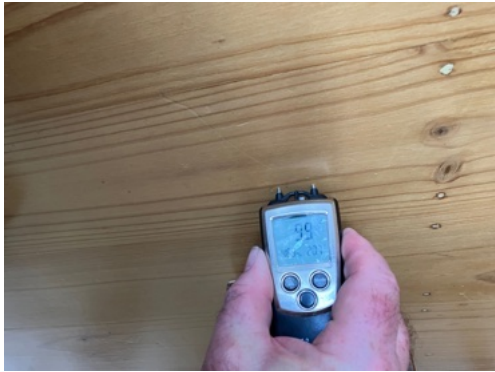
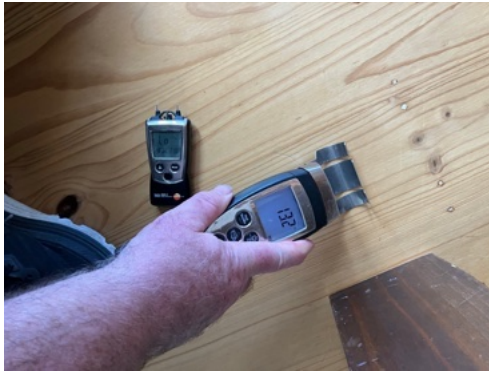
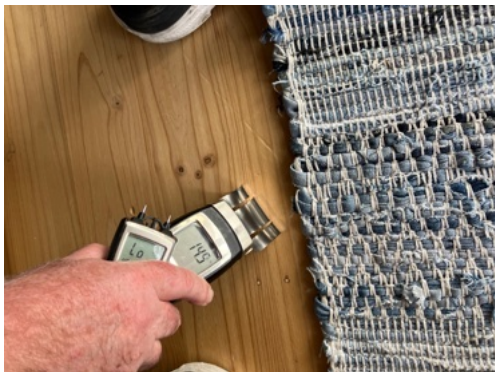
550 **18.** The rearmost area flooring was borderline damp, more so on their undersides courtesy of how the two different meters work. No cupping visible, yet.

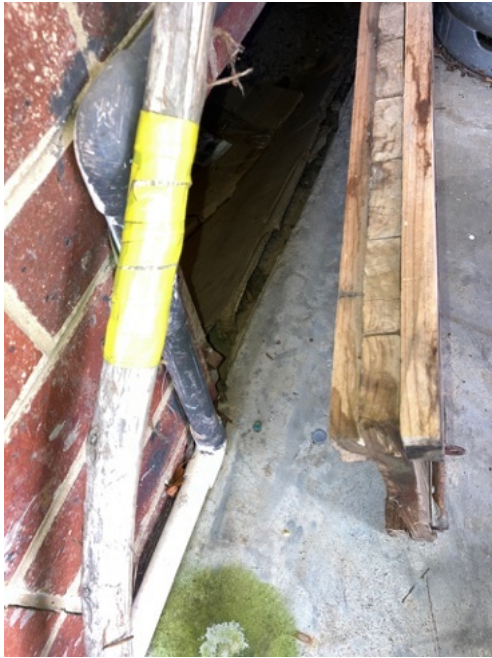
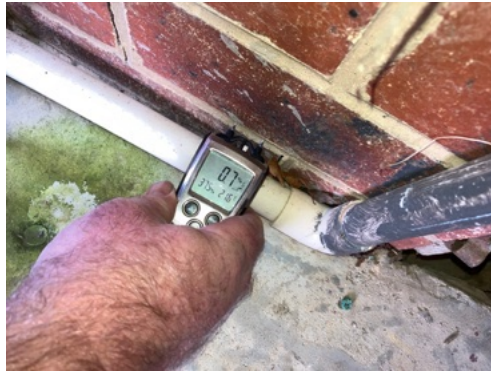
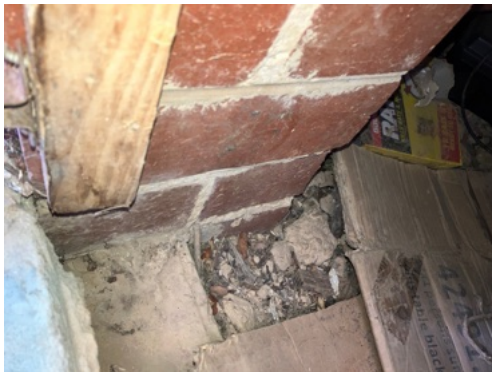
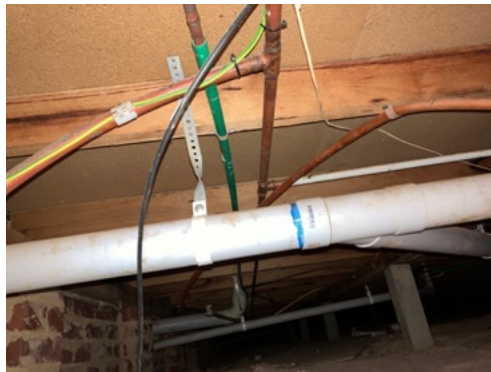
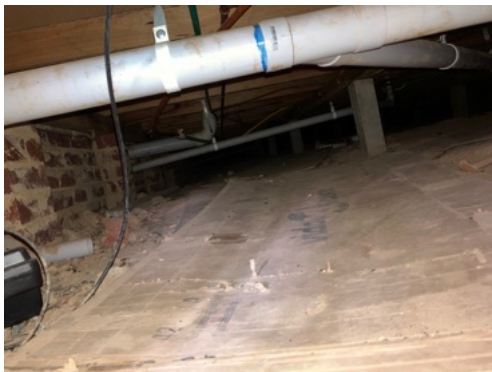
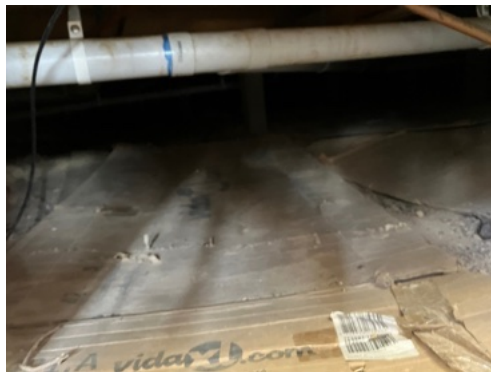
19. The subfloor hatch at the front of the house: dry and without evidence of generalised rising damp / moisture.

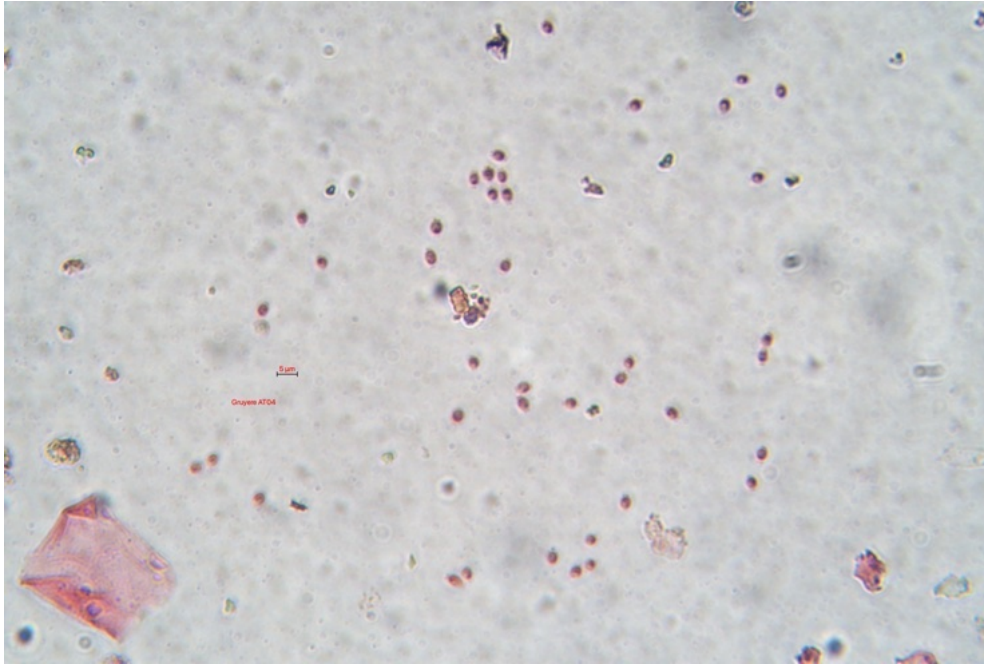
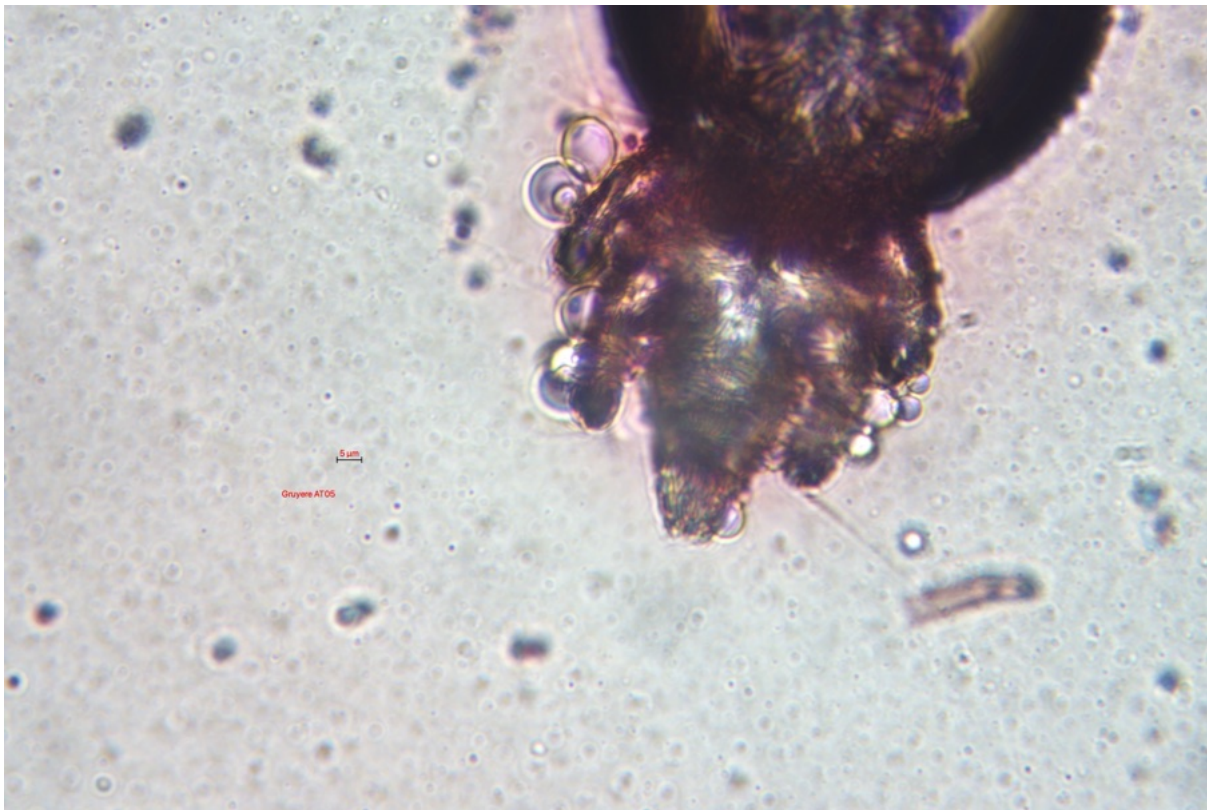
21. The total count air and surface samples: mould is stained red/magenta by this method,
585 as also skin flakes, some textiles, some insect parts. A nearly whole dust mite (or similar) is
visible with fungal spores evident around and inside it as they are known to consume such,
and flourish under similar conditions of dampness. These images represent a very minor
fraction of the entire sample examined by microscopy.

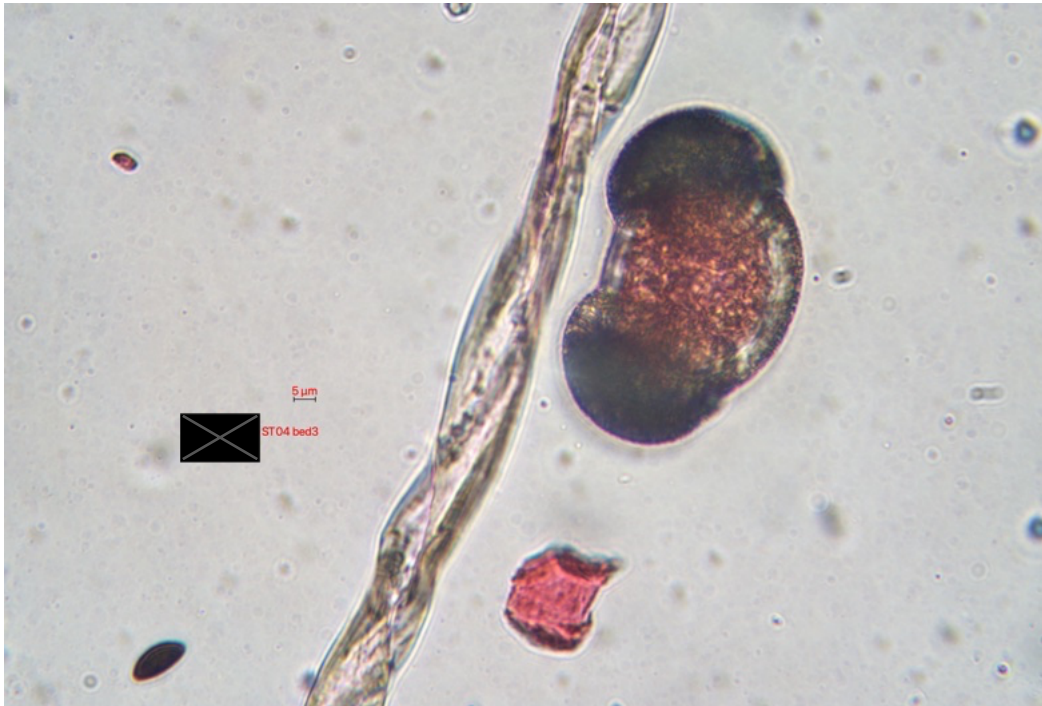
Above, pine pollen, cotton fibre, skin flake, and some spores.
