Biotopia Report ID: 200514-1 Alphington
Address: [redacted], Alphington VIC
Occupant: Unoccupied
Date of Attendance: 14 May 2020
Date of Report: 25 May 2020
Previous Report ID: N/A

EXECUTIVE SUMMARY

Extremely mouldy, rotten and at total-loss condition.

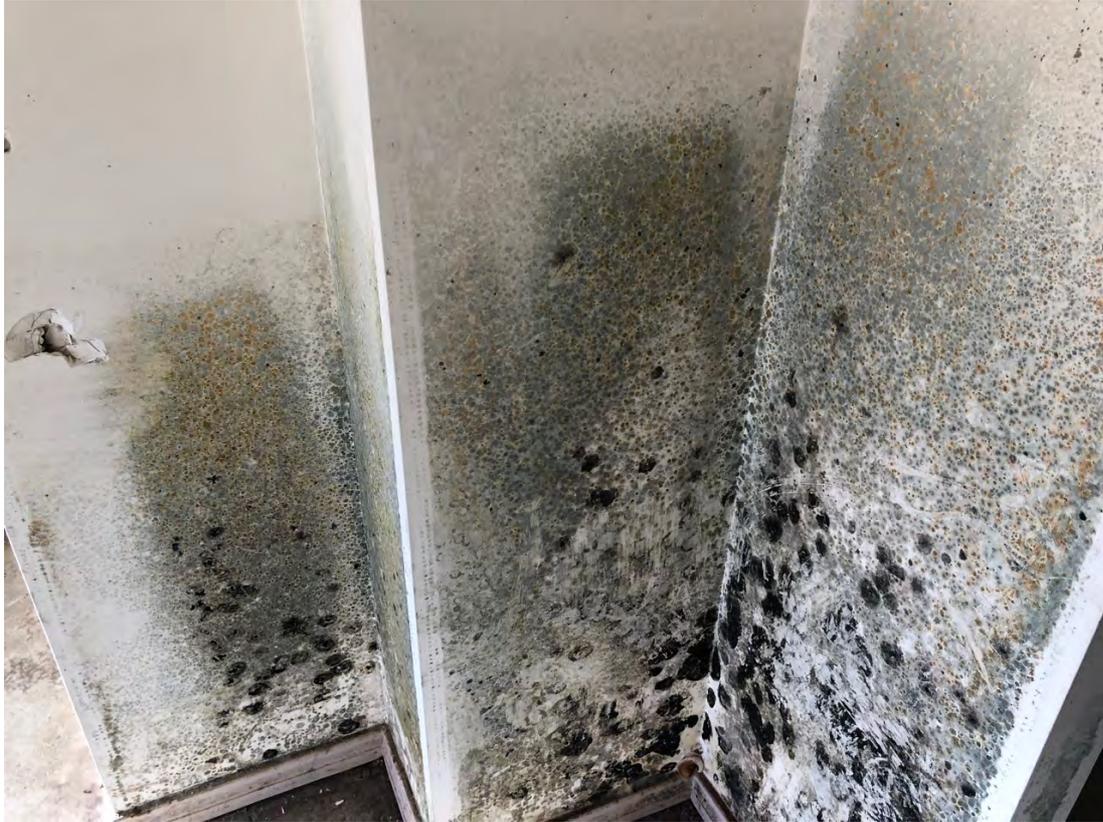
3. The detail of the entry area walls: some mould evident. Mainly *Penicillium* spp. and *Aspergillus niger* at this location. Note hole in wall, likely from some item knocking it but typical of weakness of cardboard backing within the wall cavity due to even greater mould activity and dampness.

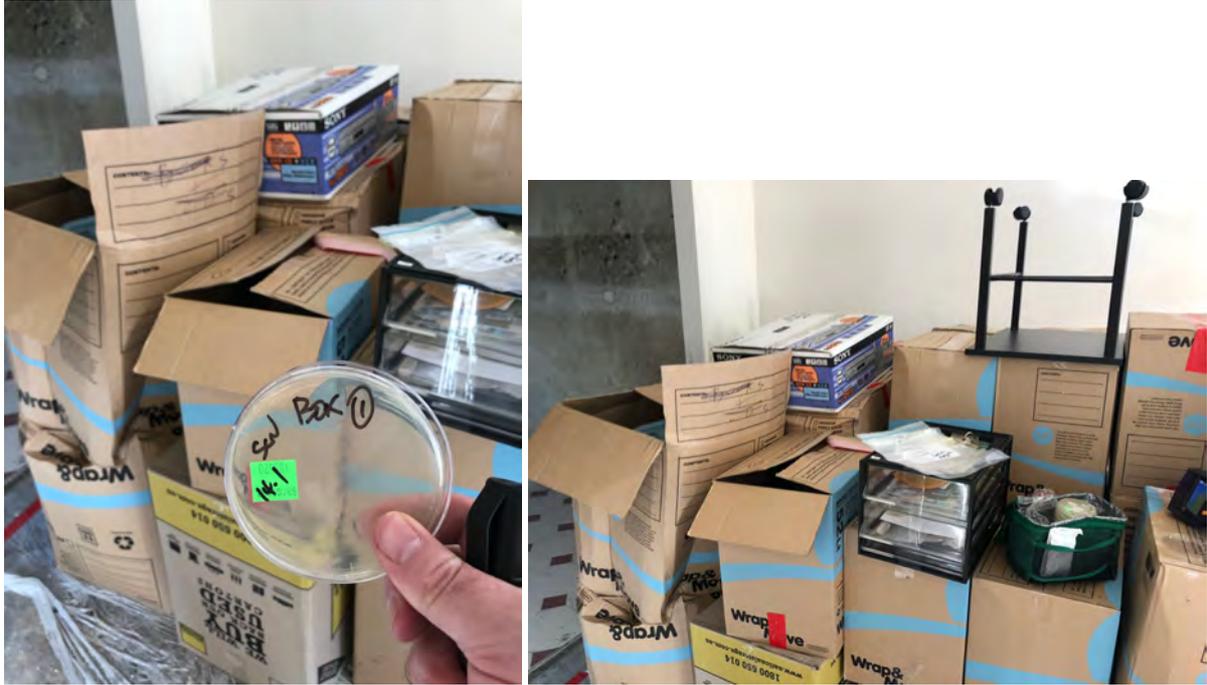
4. The living room: boxes of contents items, as sampled.

- 3.5. Discard all contents items not able to be run through a dishwasher, or of extreme sentimental / monetary value. Do not re-use the cardboard boxes. Ensure mini-skips are covered and very mouldy items are wrapped/bagged to prevent escape of contaminated dusts into local area where there are several residents nearby.

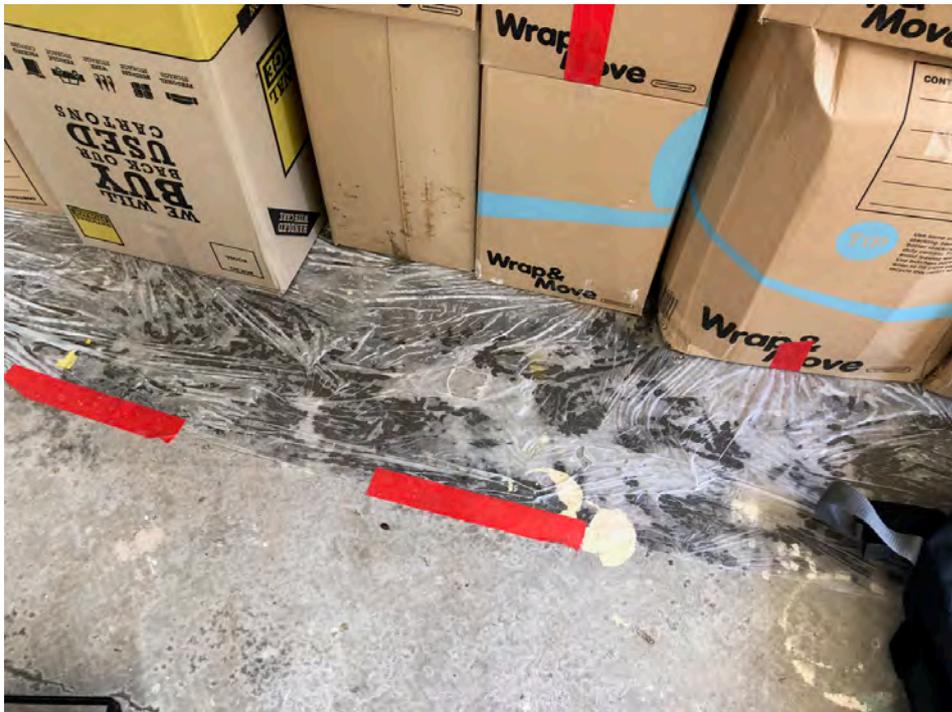
5. The plastic on the living room slab: condensation noted underneath indicating slab dampness.

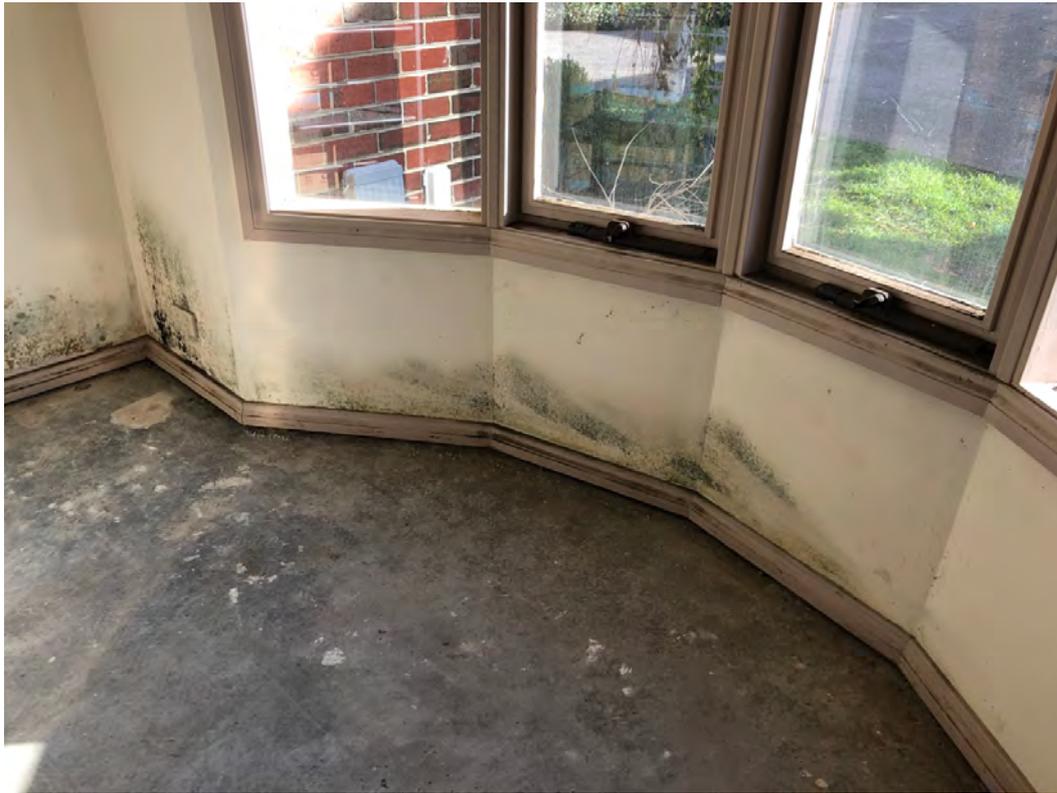
Most window frames have also suffered from condensation running down the panes causing rot/mould.

6. The living room area / front bay windows. Noted rot of window frames from condensation. Wall to adjoining property is to left.

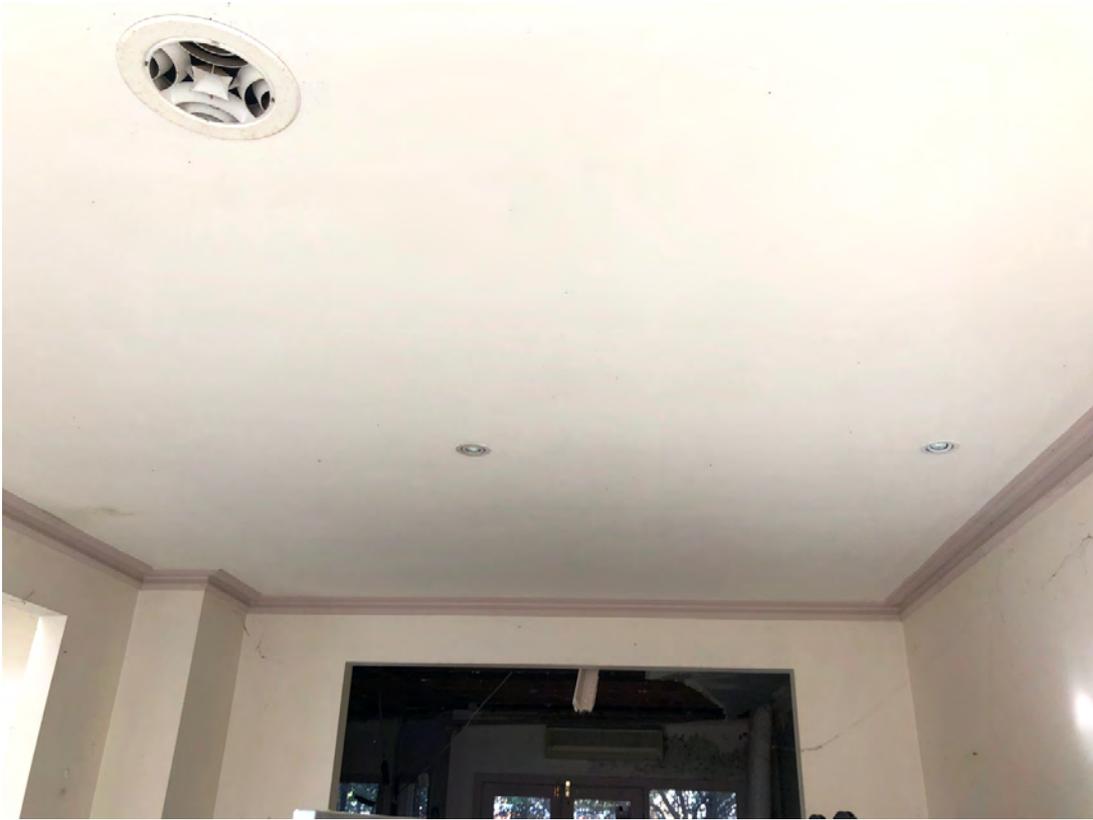
7. The living room ceiling: heating ducts, downlights. Visible mould patches.

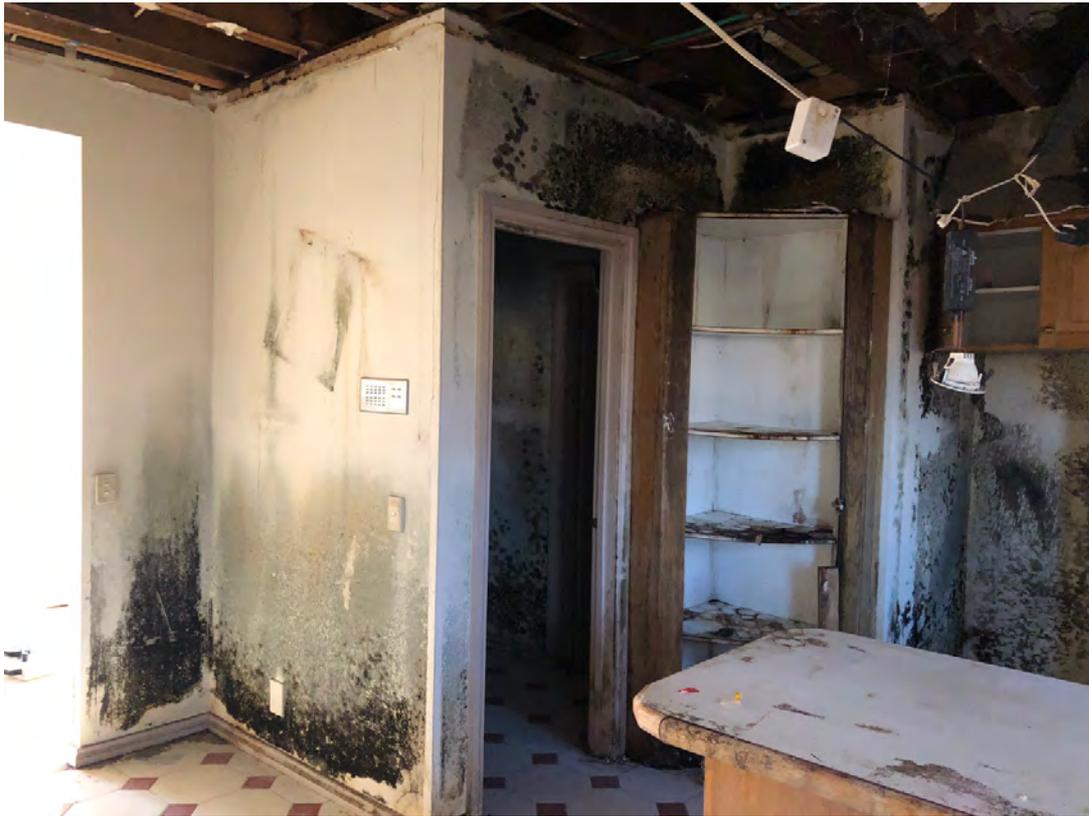
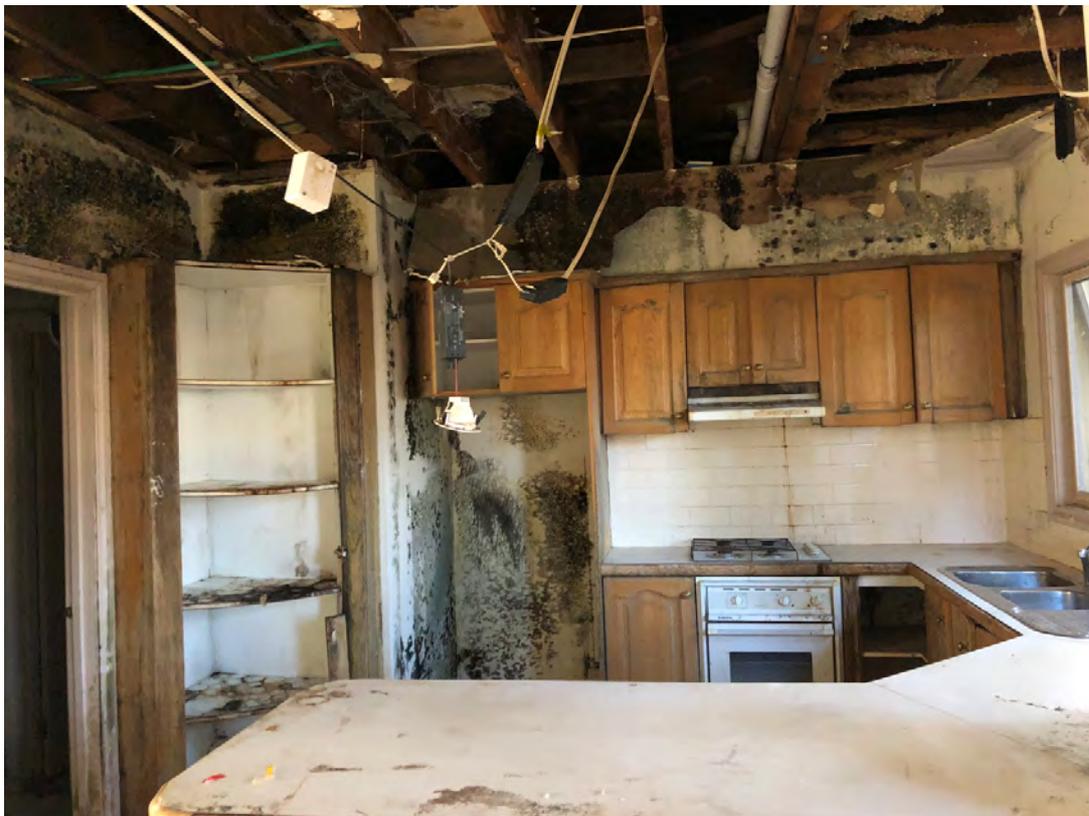
8. The kitchen. Some mould may be visible. Note missing ceiling.

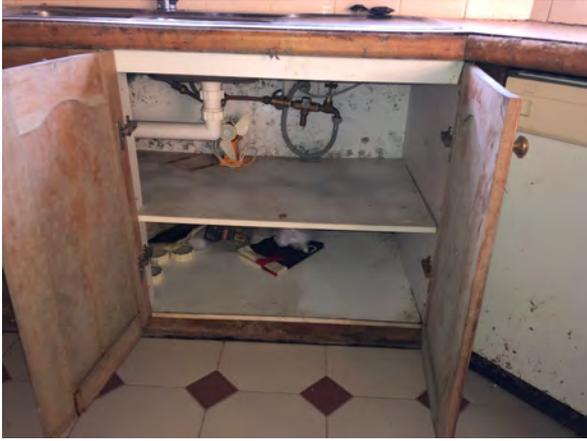
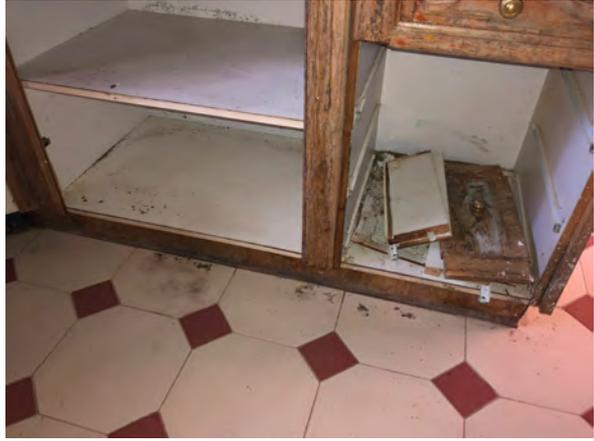
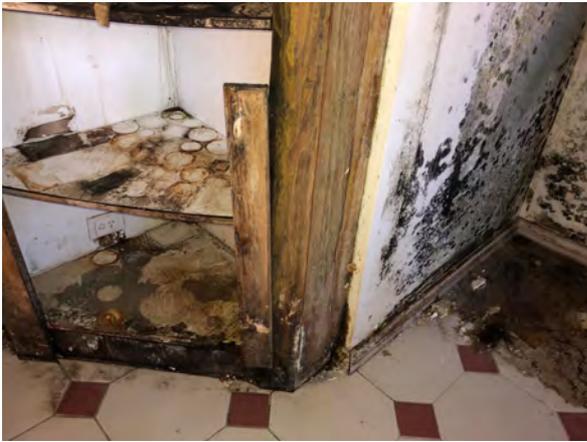
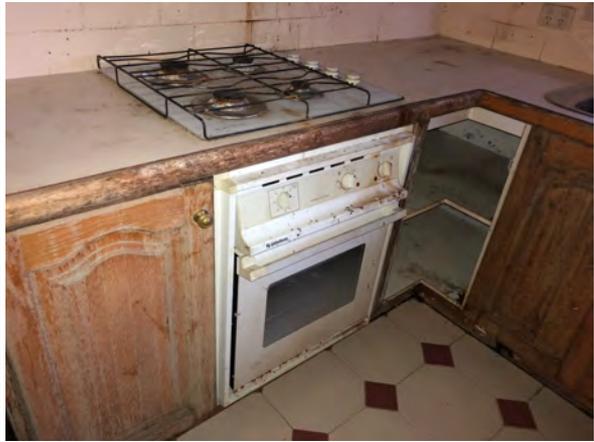
9. The kitchen cabinets: seen better days.

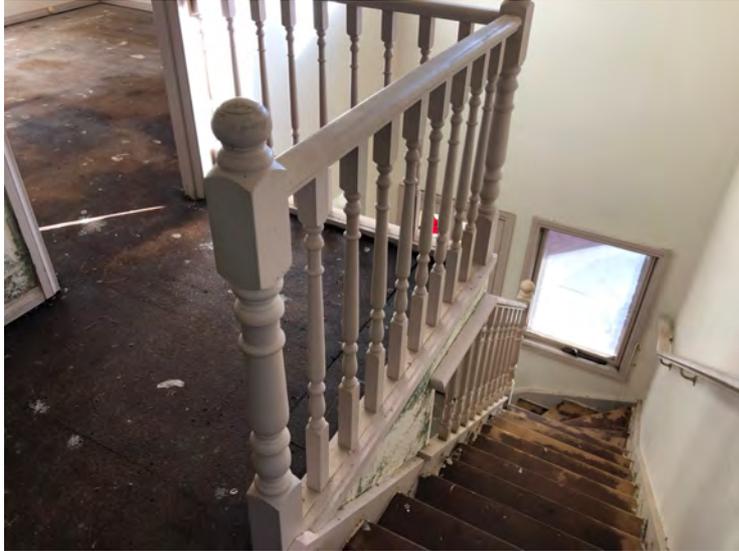
13. The upstairs landing. Chipboard squishy.

- 3.4. Check the structural integrity / safety / load-bearing capacity of the MDF stairs and upstairs yellowtongue flooring, and consider pulling down the ceilings downstairs before they fall down unexpectedly.

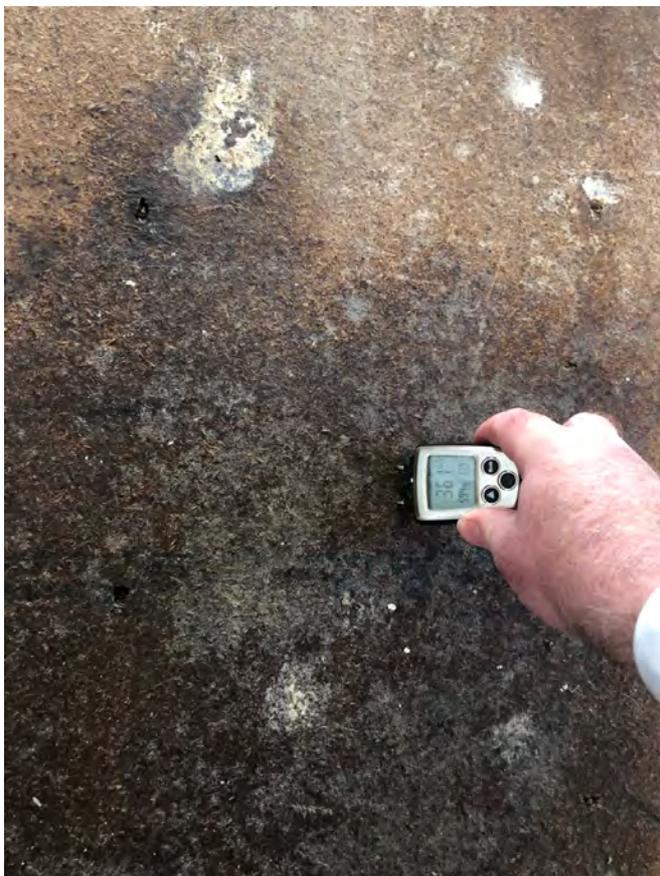
17. The chipboard was soggy, spongy and wet, with visible mould growth and rot.

- 3.9. Remove stairs and upstairs flooring to better access the salvageable timber members. May need to put down temporary duck-boards and steps/ladder.
