**Biotopia
Environmental
Assessment**

ENVIRONMENTAL ASSESSMENT REPORT

Report ID: 240830-1 [REDACTED]
Property: [REDACTED] VIC
Assessment date: 30 August 2024
Report for: [REDACTED]
Date of Report: 11 September 2024
Previous Report ID: N/A

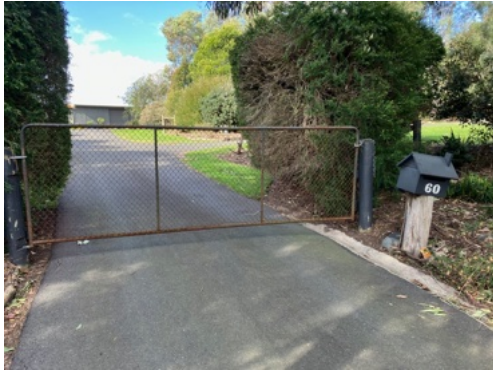
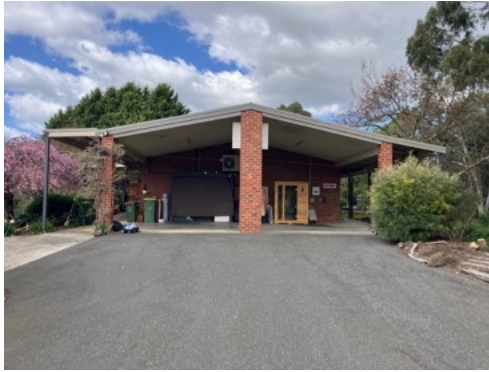
1. The front of the property and house.

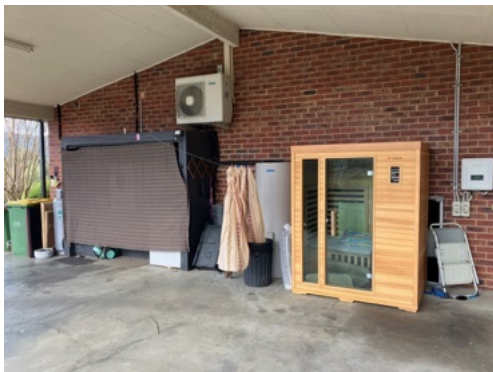
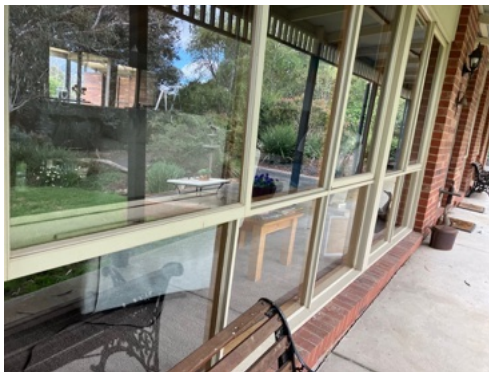
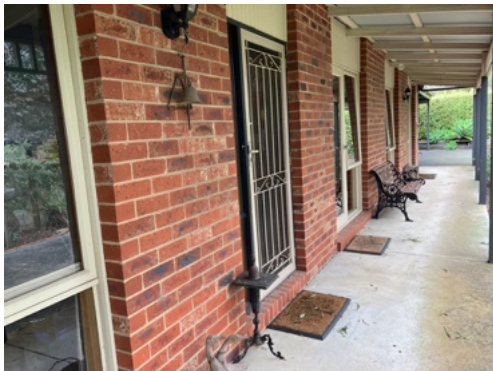
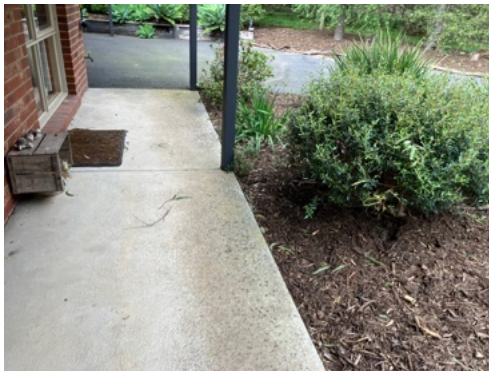
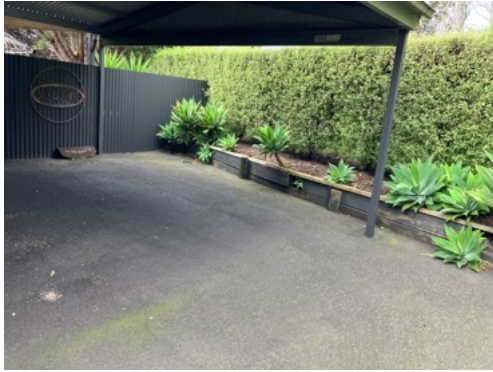
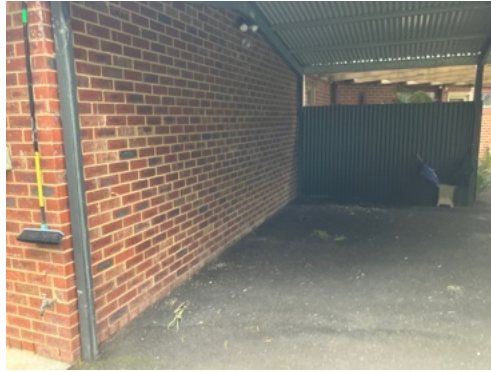
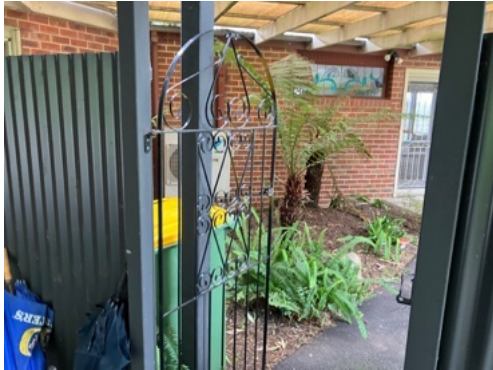
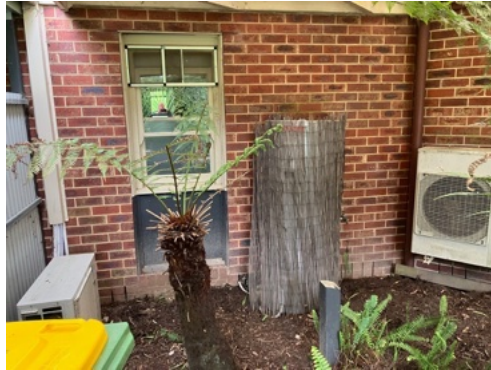
2. The externals, starting at the front carport, then around the high-side of the house, etc.

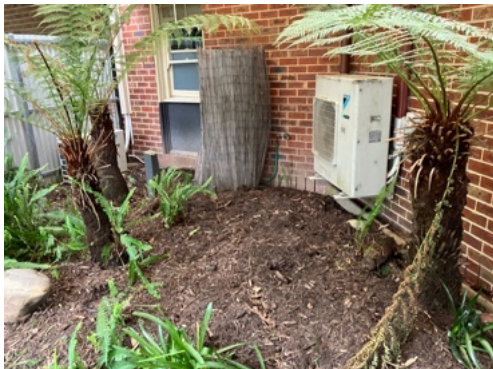
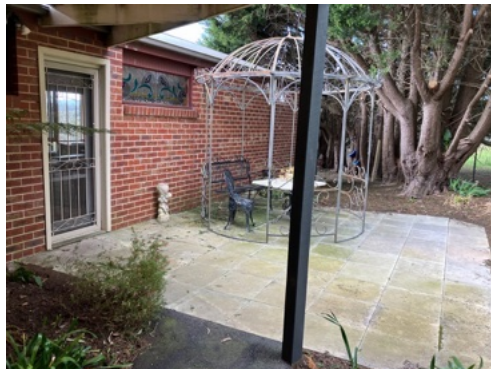
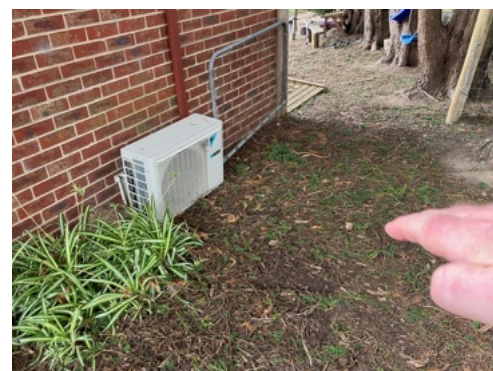
hot water system at central bathroom window

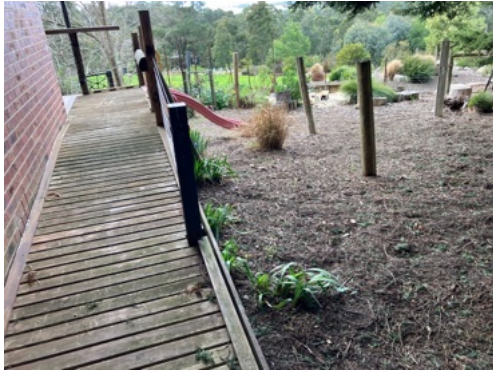
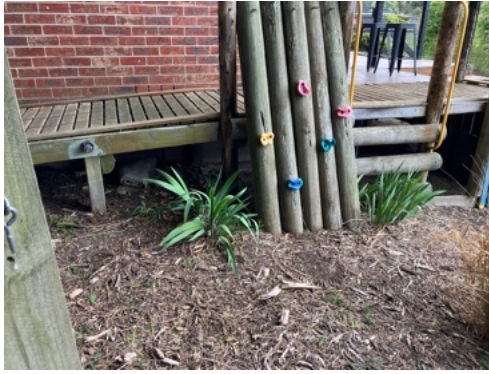
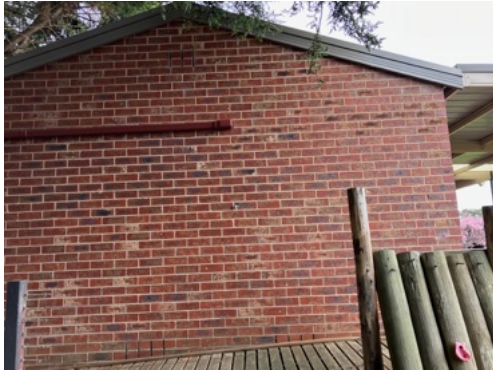
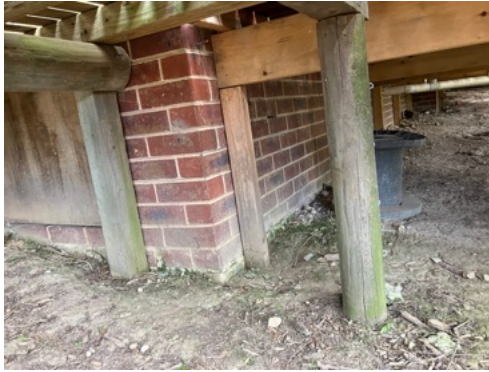
ground slopes away from house

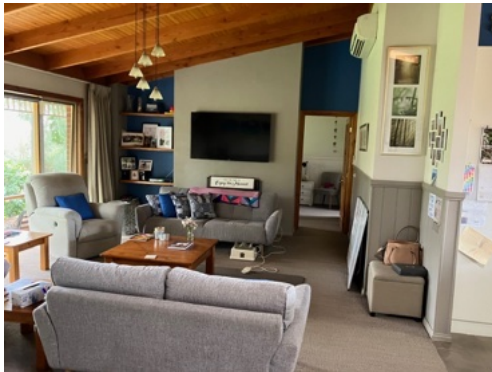
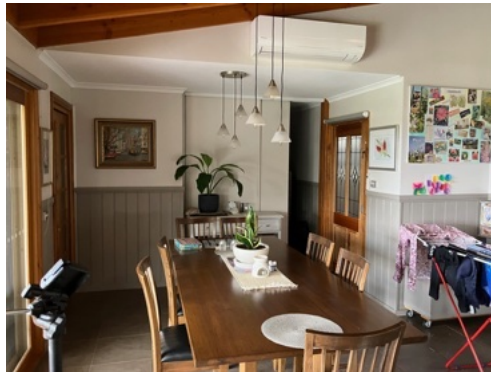
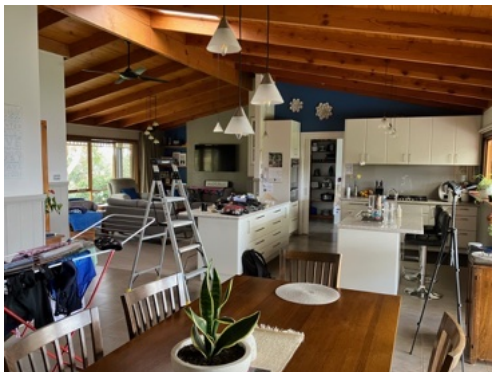
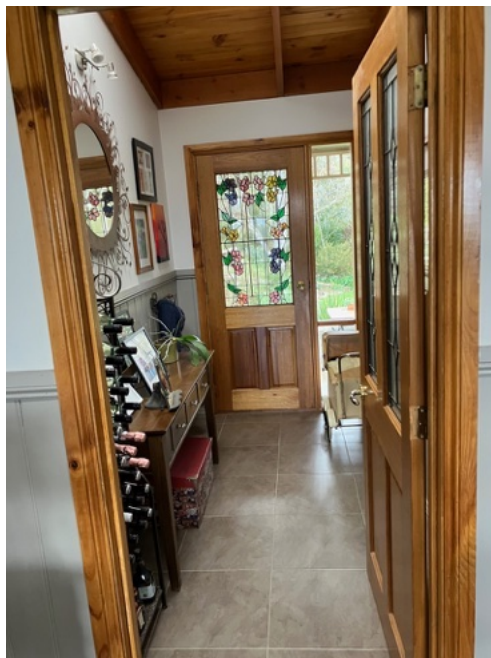
3. The front area open-plan kitchen, dining, living.

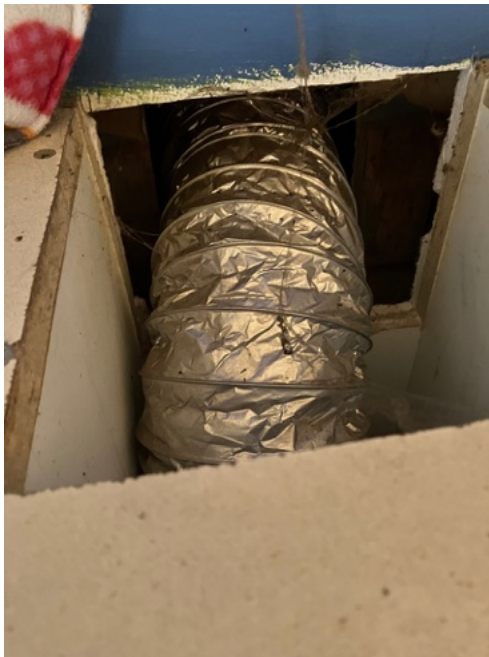
5. The rangehood flow seemed OK, and was plumbed out of the kitchen.

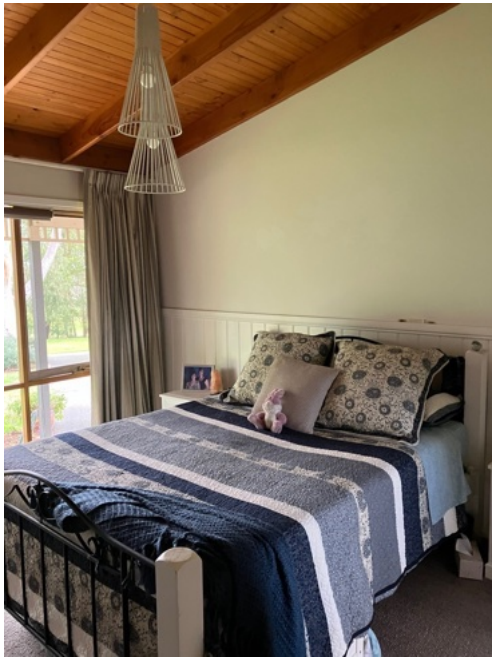
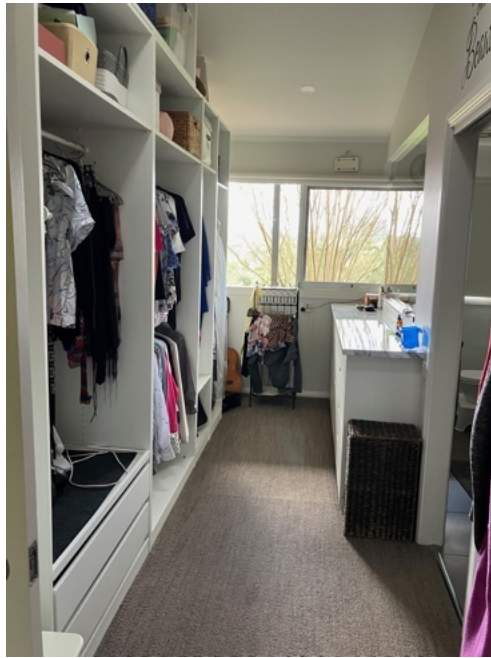
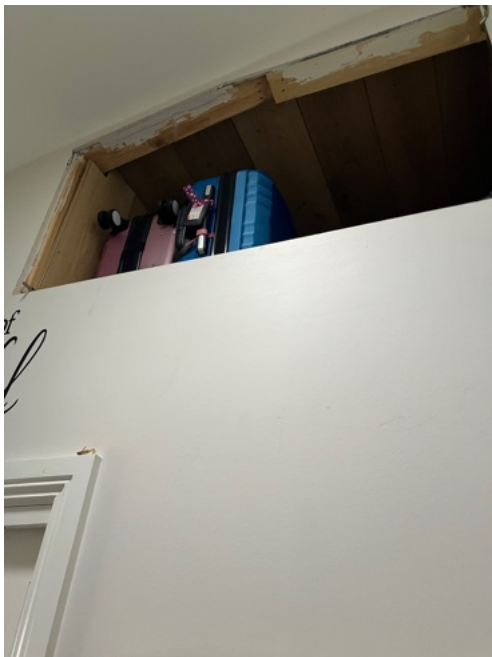
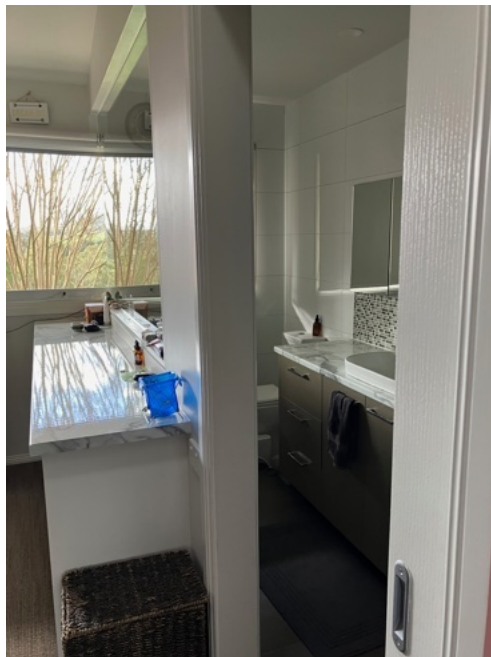
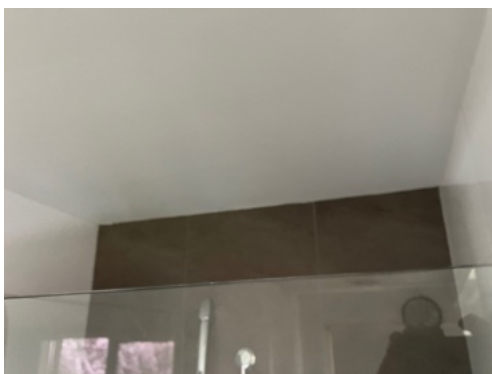
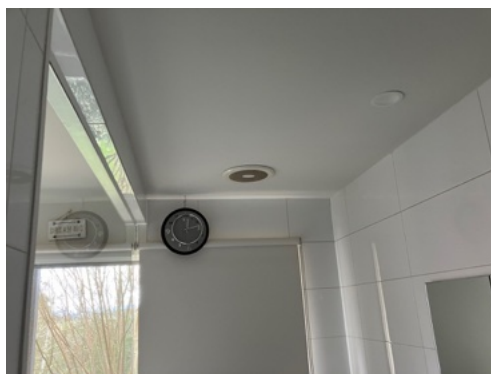
6. The master bedroom, its WIR, storage hatch, ES bathroom.

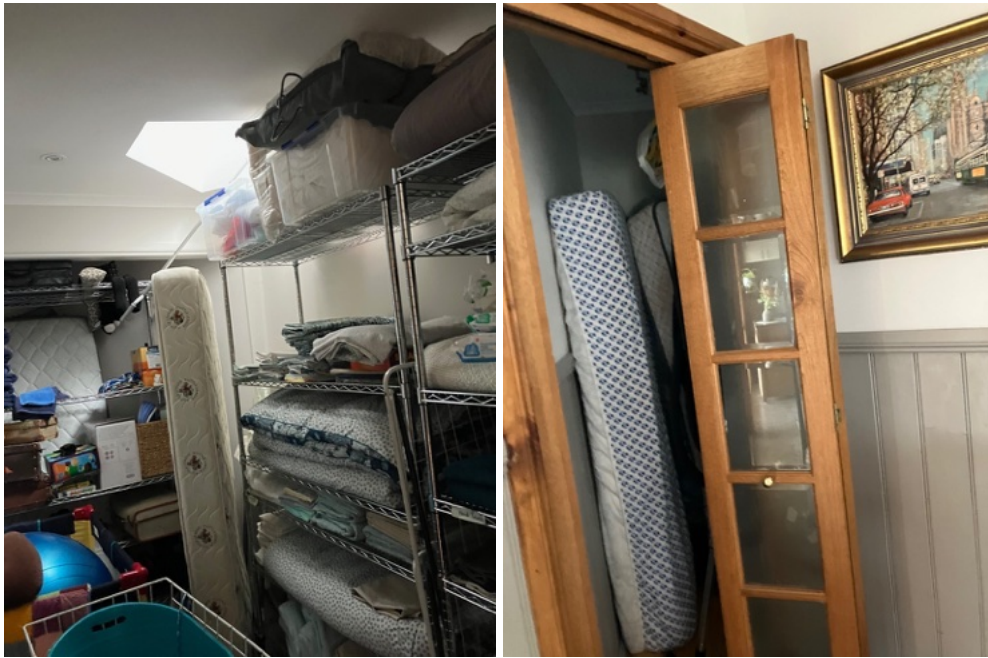
8. The storage areas to rear of front kitchen/dining.

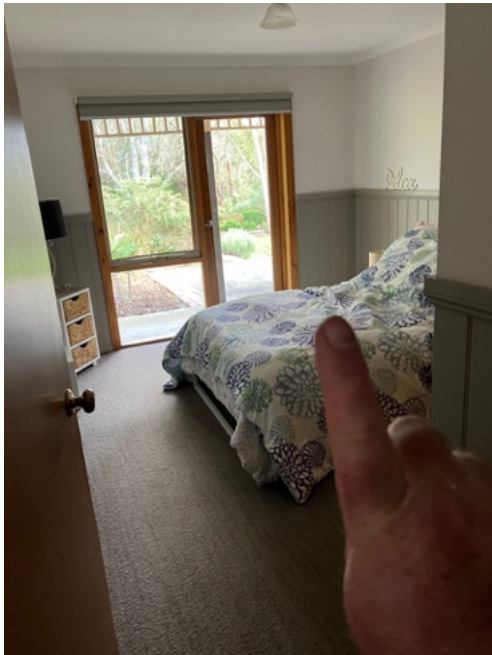
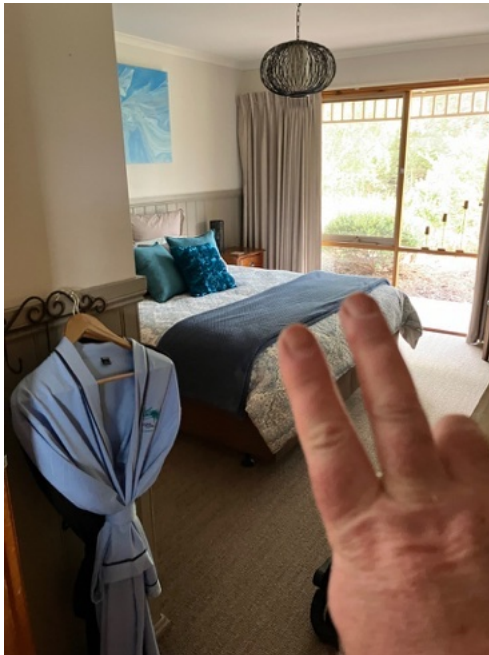
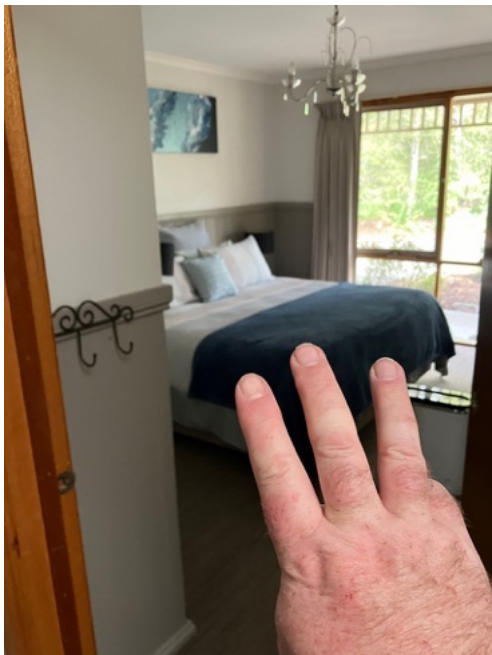
9. The small side/rear bedrooms 1, 2 and 3, as digitally indicated.

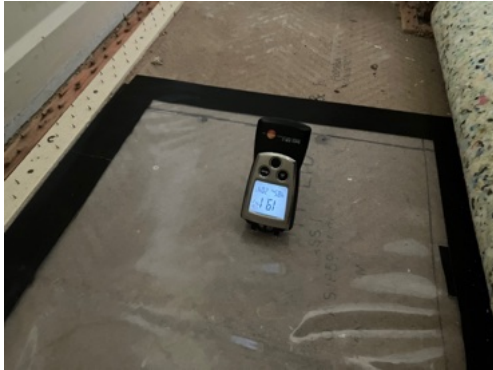
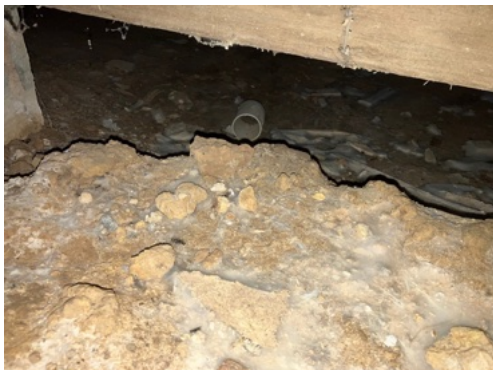
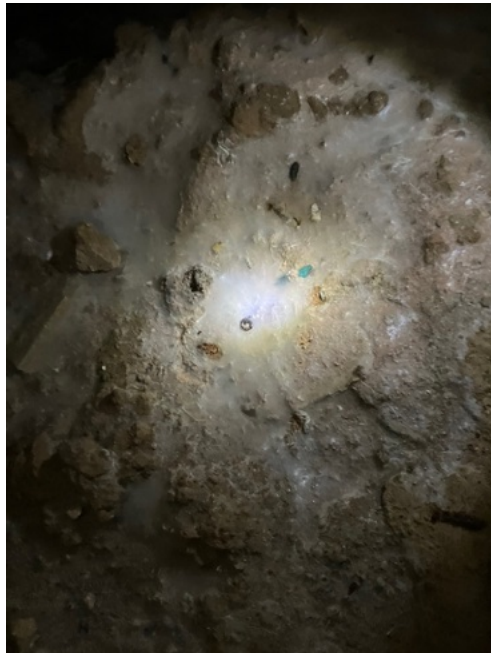
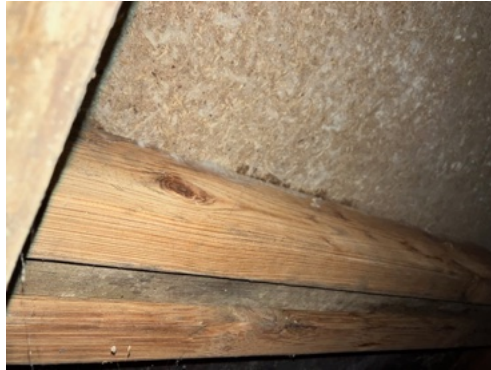
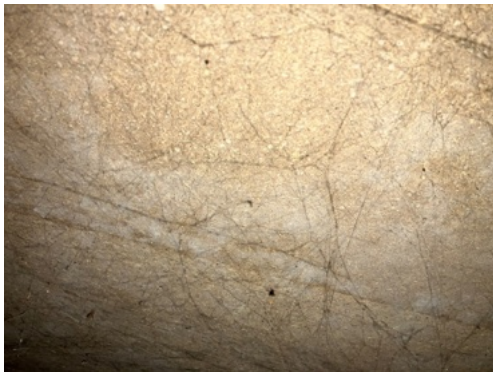
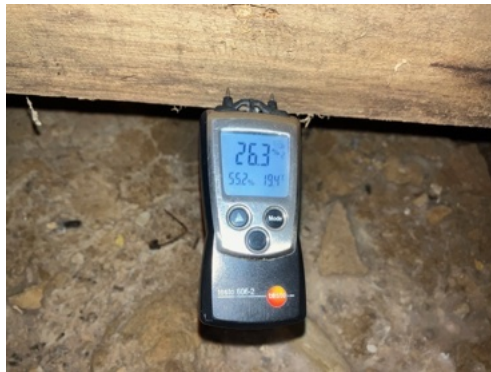
495 **12.** The bedroom 3 hatch into subfloor in the BIR adjacent to the bathroom shower. Hatch
chipboard is wet as also other timbers. Strong mould and geosmin odours. The subfloor soil
surface was wet and covered with a strange fibrous substance that may have been great
amounts of fungal hyphae, but this is unclear. Definitely the underside of the chipboard
flooring was visibly mouldy (pale dusts often in fingerprint sized colonies / patches, as typical
500 of *Penicillium* and some *Aspergillus* species in these conditions). Soil is heaped up at this
exact location, but slopes off to a possible height of about 300 mm at the high-side of the house
to about 700 mm – 1 m at the low side. It is theoretically possible for a person to crawl under
the house, but would be quite difficult to get under the bathroom and bedrooms in a manner to
effect meaningful remediation.

Remediation of the subfloor would likely require removal of flooring of bedroom and bathroom.

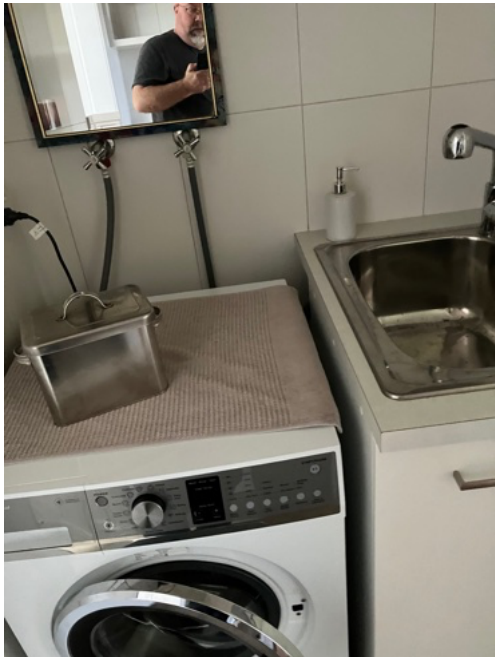
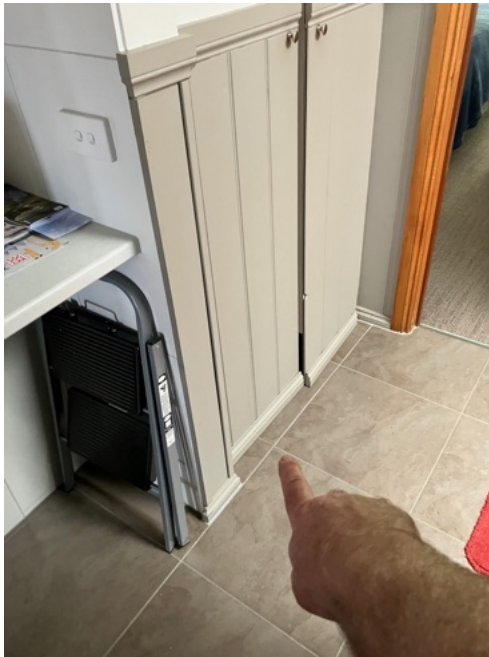
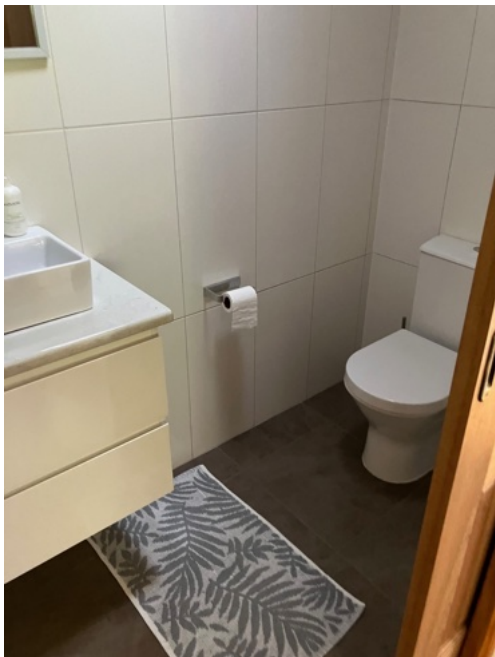
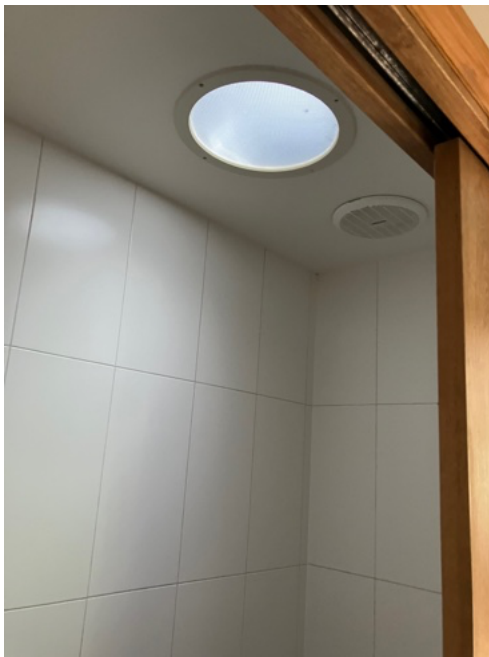
- 515 **13.** The hallway between front and rear sections of the house, with laundry, toilet, small cupboard to rear of the central bathroom shower. Tumble dryer is located outdoors under the front carport.

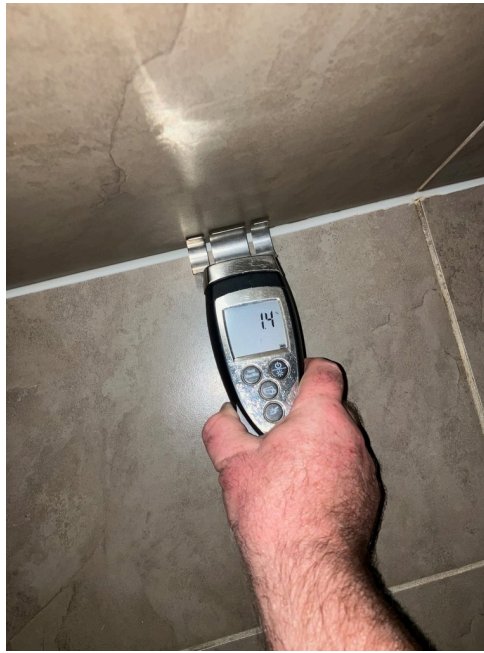
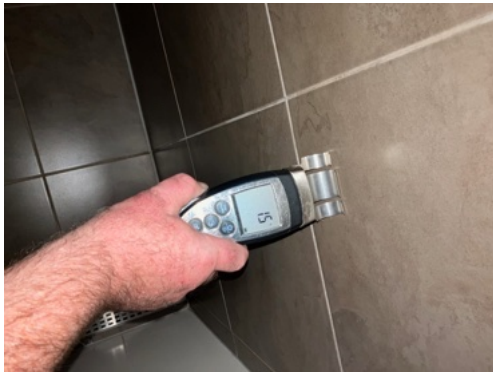
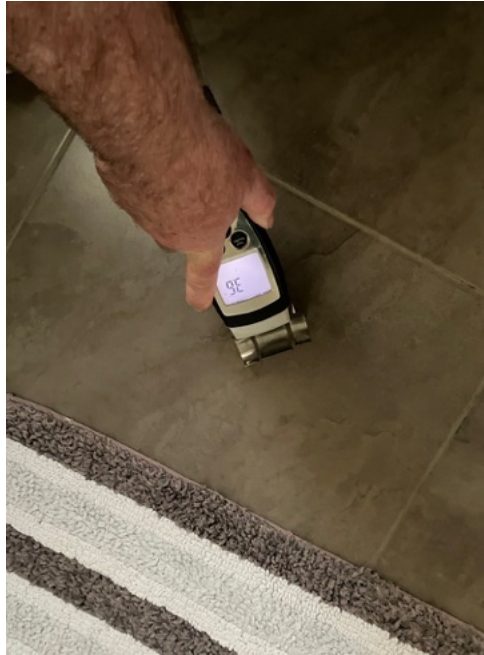
15. The central bathroom. Shower base is damp, walls dry, but not consistent with an actual leak from the shower, instead more consistent with significant dampness below the shower base and elsewhere under the tiles.

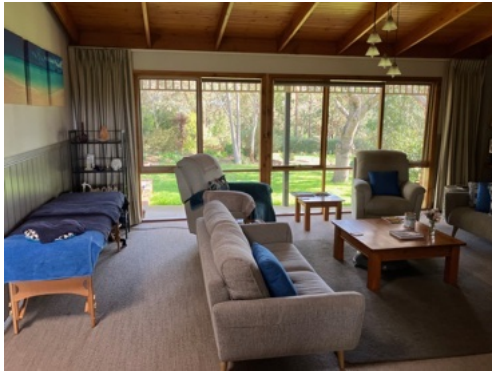
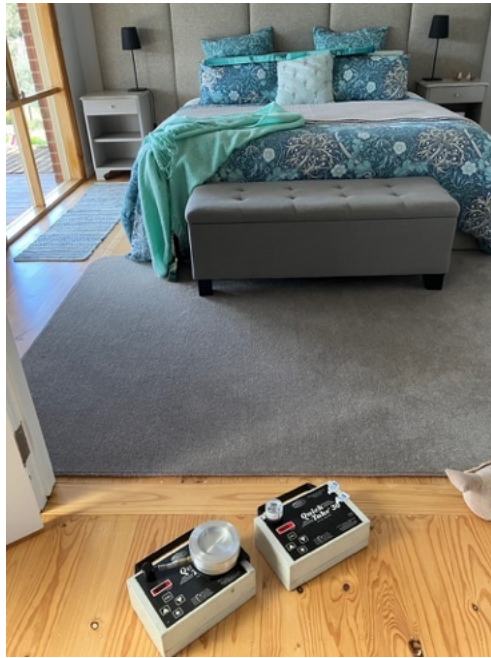
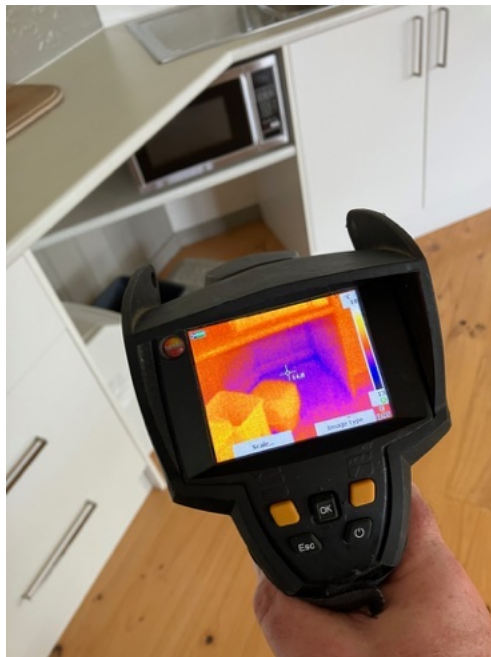
545 17. The rearmost kitchenette, bedroom.

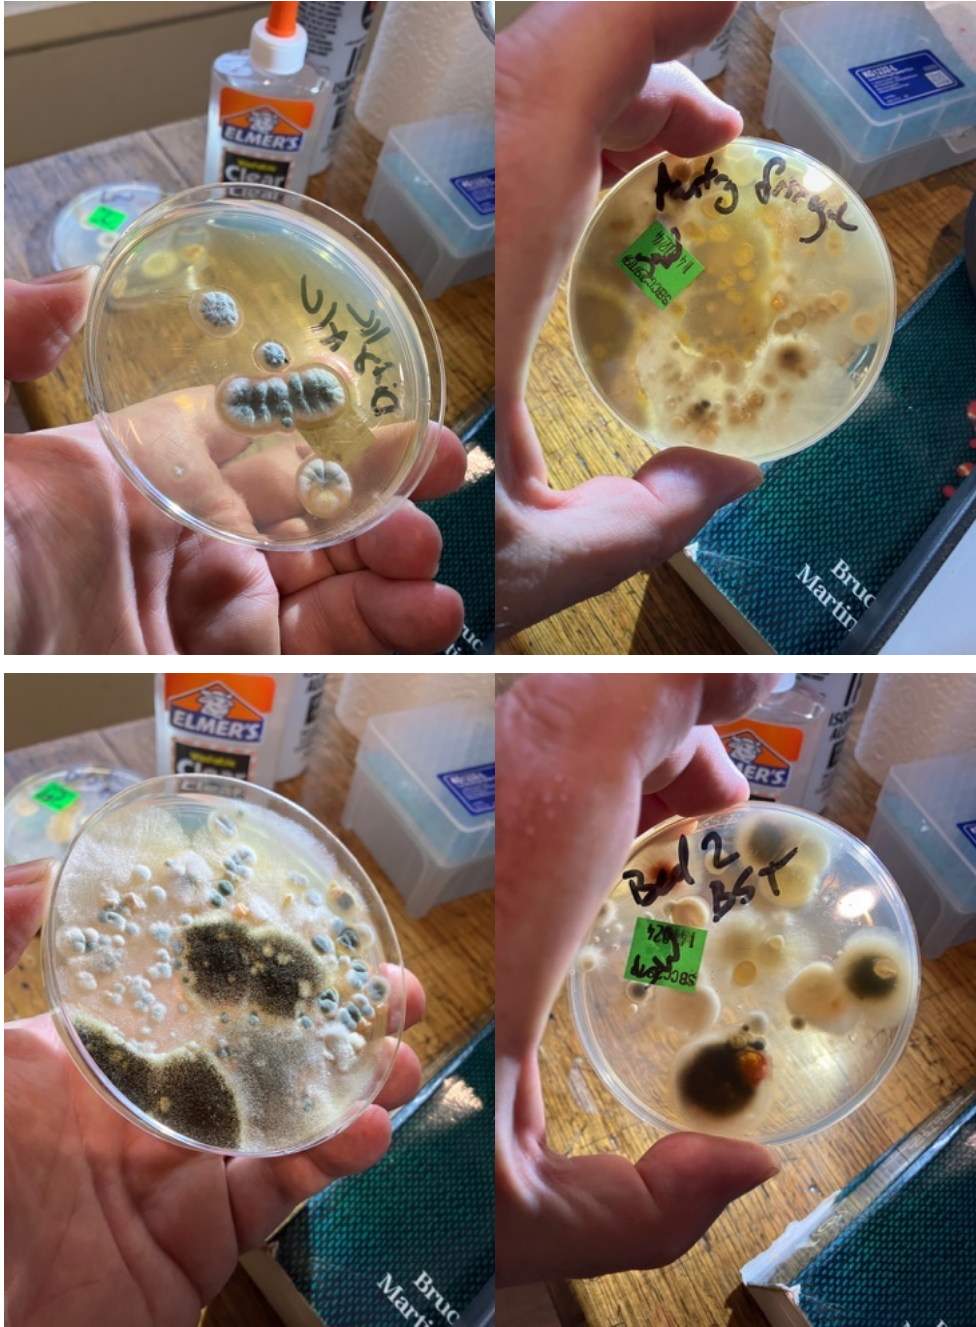
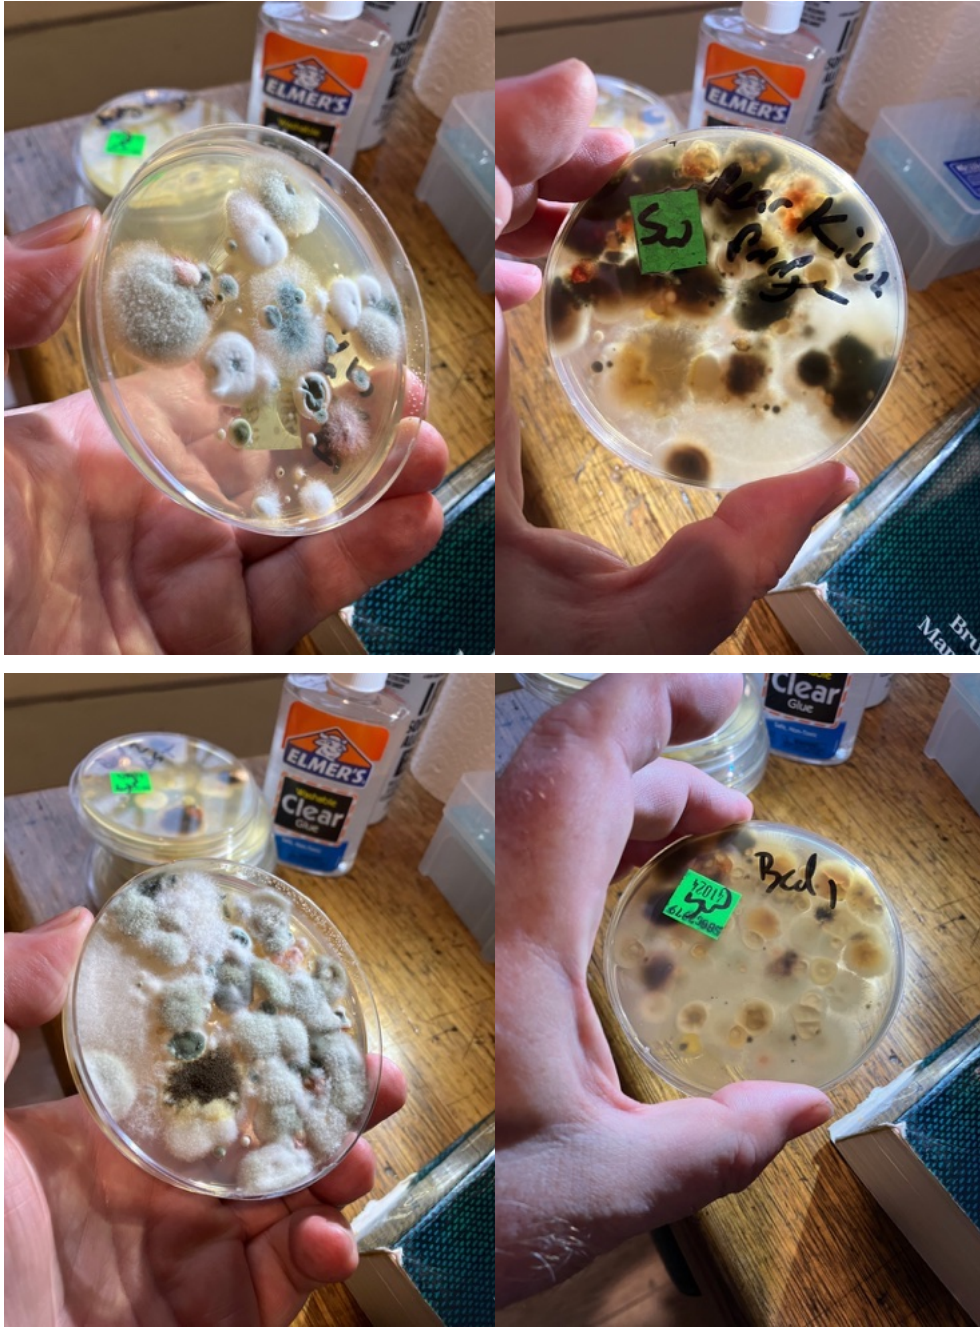
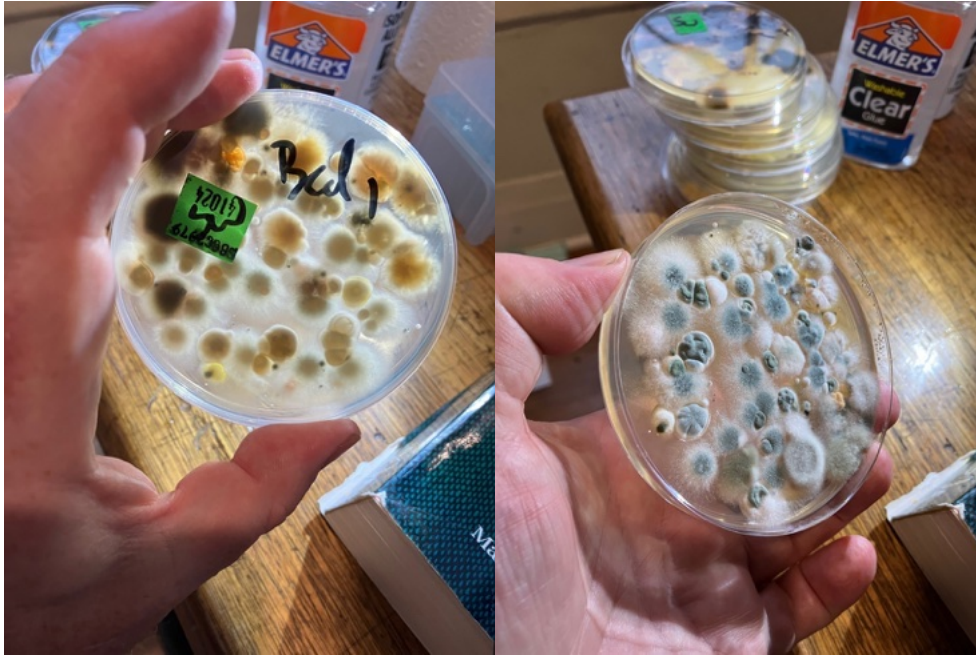
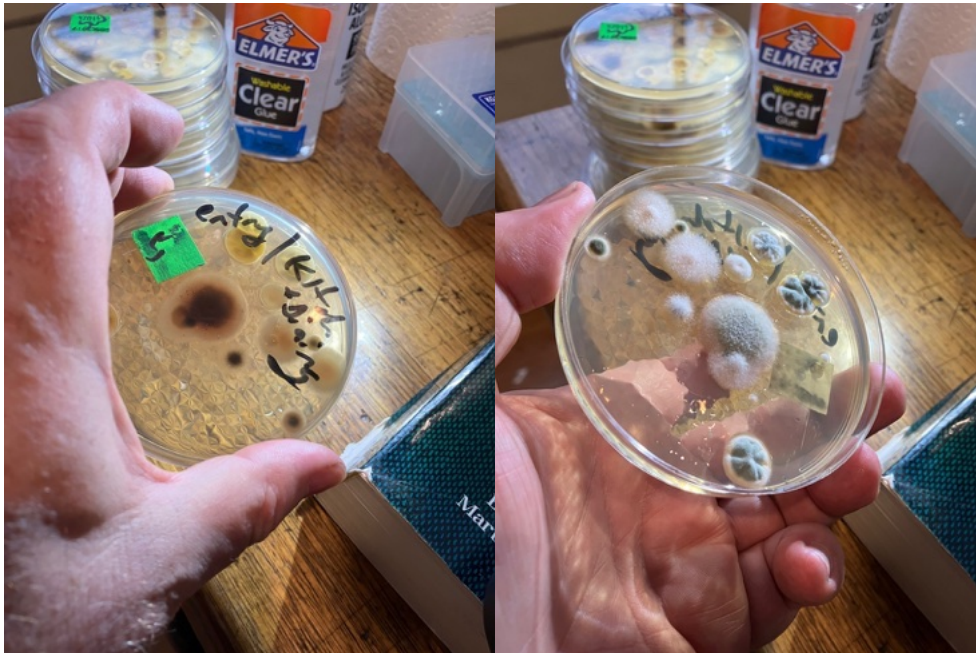
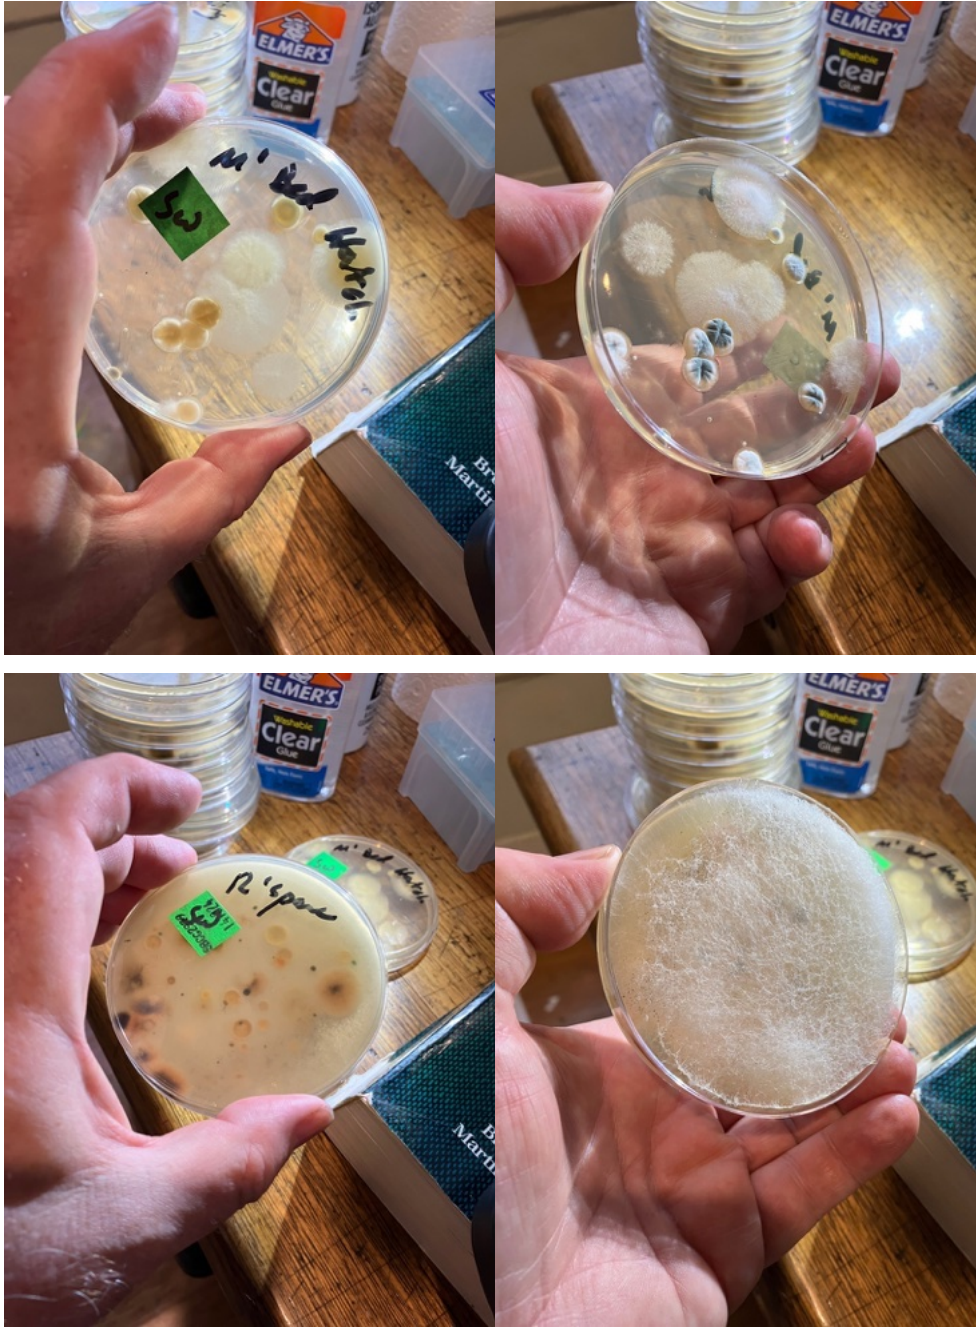
20. The viable surface and air samples after incubation.
